**STEWART**

RE: Grey Hosiery Mill Structural Assessment  
Hendersonville, NC

**PROJECT BACKGROUND AND DESCRIPTION**

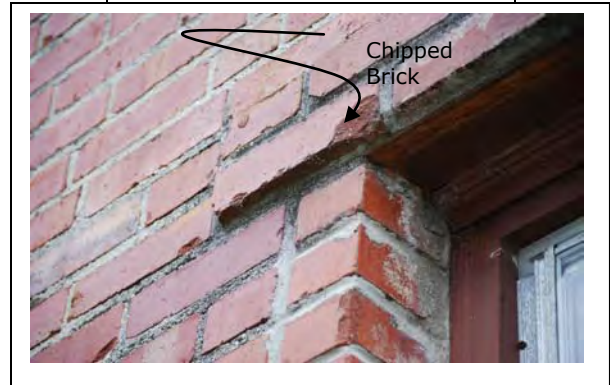
Photo 1.8

- Water staining was found in four locations between grid C and the west end of the building. See **Photos 1.8, & 1.11**.
- Repointing of the brick is required above the window near the west end of the building. See **Photo 1.7**.
- Significant concrete spalling has occurred at the concrete knee wall supporting the brick at the west end of the building. See **Photo 1.6**.

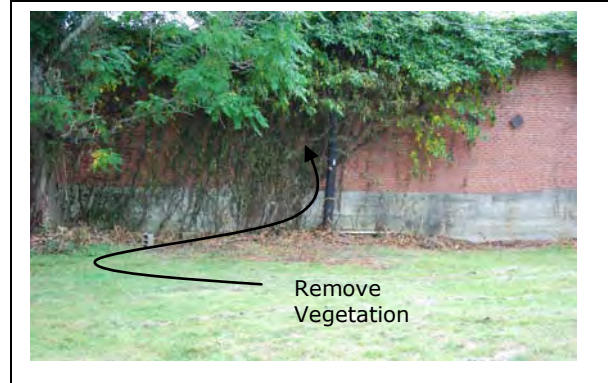
Photo 1.18

- Excessive growth of vegetation over the brick and concrete walls between grids Q and D. See **Photos 1.16 – 1.20**.
- A hole exists in the brick wall just above the stone masonry near grid I. See **Photos 1.17 & 1.19**.
- Significant concrete spalling has occurred at the concrete knee wall supporting the brick between grids D and C. See **Photos 1.12 & 1.13**.
- A section of brick has spalled at approximately fourteen brick courses above the door near grid C. See **Photo 1.14**.
- The steel lintels supporting the brick above the windows are rusted; this is typical for the five windows between grid D and the west end of the building. See **Photos 1.9, 1.10, & 1.15**.
- The wood door and wood door frame is starting to rot. Multiple glass panes are missing from the door frame. The steel lintel supporting the brick above the door is rusted. See **Photo 1.5**.

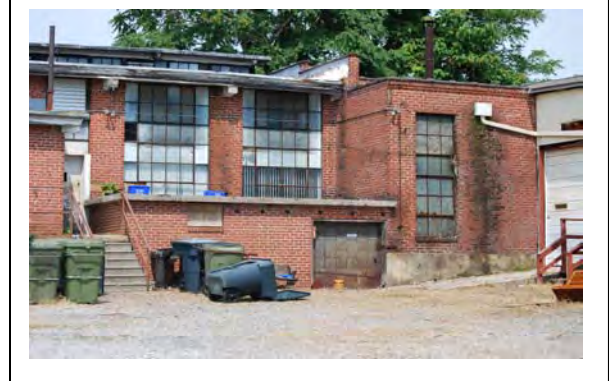
Photo 2.27

- A cracked window pane exists in the window frame between grids 6.4 and 5.9. See **Photo 2.27**.
- A crack exists in the mortar joints of the brick between the window frames near grid 5.9. See **Photo 2.58**.

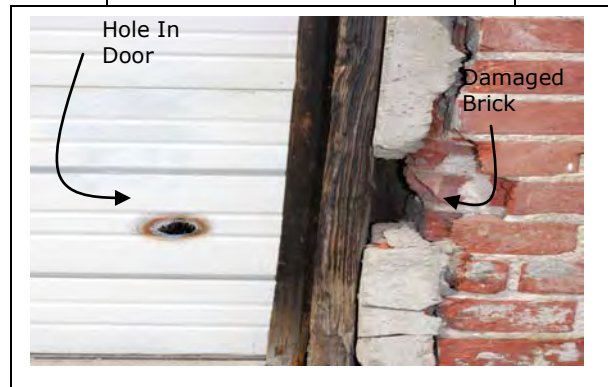
Photo 2.36

- Several bricks on each side of the overhead door at the loading dock have been broken. It appears a fix was conducted by way of concrete infill, but that has undergone damage as well. See **Photos 2.30 & 2.36**.

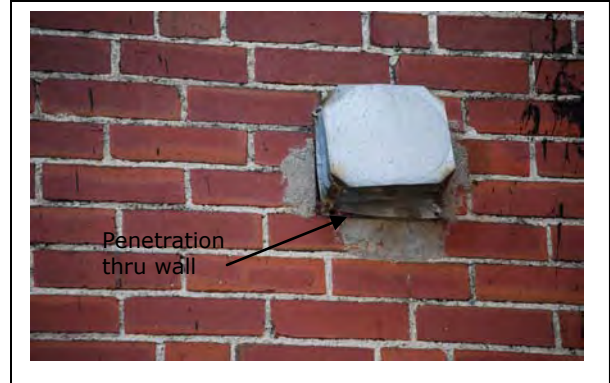
Photo 2.80

- Several holes exist in the brick in addition to a broken window pane and repointing of brick required at the north-facing bump-out wall between grid 12 and 11.5. See **Photos 2.78 - 2.81**.

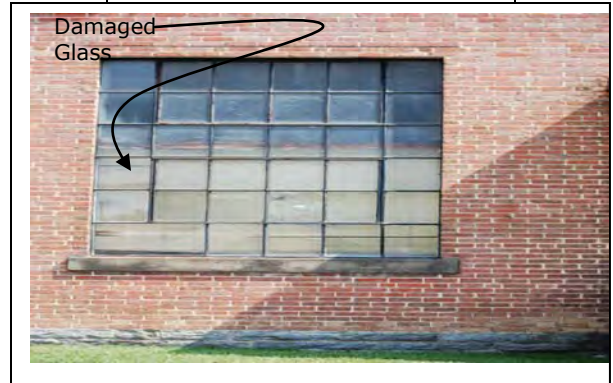
Photo 3.3

- Four cracked window panes exist in the steel window frame west of grid B. See **Photo 3.4**.
- At the window openings on each side of grid B, the steel lintels have rusted. See **Photo 3.3**.
- The wood canopy at the first entry from the left has rotted. See **Photo 3.7**.
- A chipped stair tread exists at the top of the concrete steps leading to the first entry. See **Photo 3.5**.

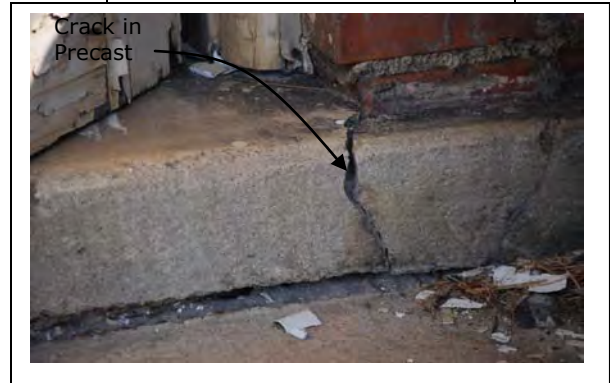
Photo 3.20

- Several cracks exist in the precast door sill at the right side of the main entry. See **Photo 3.20**.
- The wood handrail and roof fascia of the main entry canopy have rotted. See **Photo 3.9, 3.21, & 3.22**.

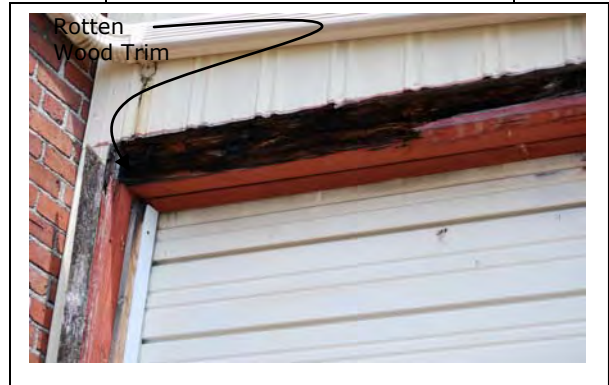
Photo 3.55

- A crack exists in the concrete ramp leading to the overhead door between grid H and I. See **Photo 3.55**.
- The wood fascia around the overhead door between grid H and I has rotted. See **Photos 3.55 – 3.57**.

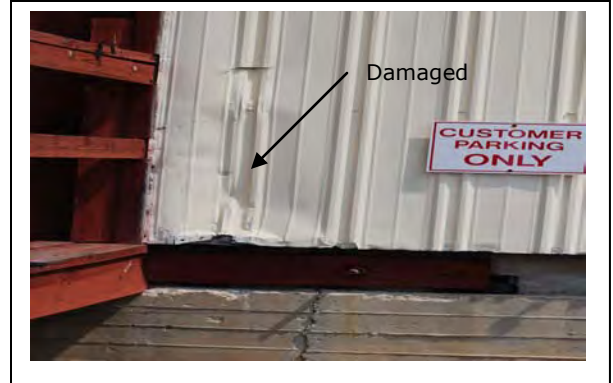
Photo 3.63

- The aluminum siding has been significantly damaged in two locations between grids J and K. See **Photo 3.54**.
- Aluminum panel soffit is missing from grid H to just past grid J. See **Photos 3.54, 3.62, 3.63, 3.67, & 3.68**.

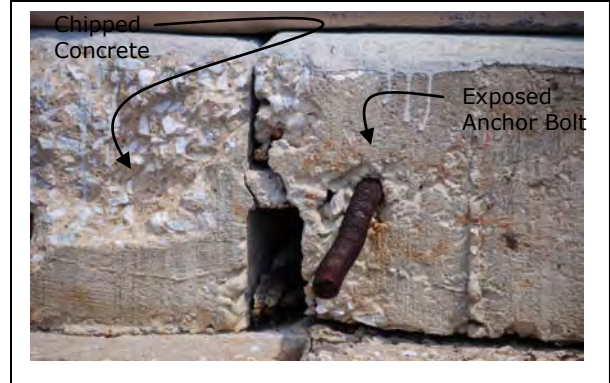
Photo 3.71

- Chipping of the concrete slab has occurred between grids J and K. See **Photos 3.54, 3.71 – 3.73**.
- A crack exists in the concrete beam between grids J and K. See **Photo 3.54**.

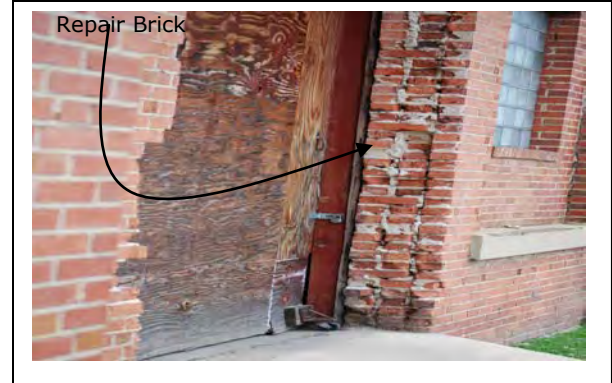
Photo 4.47

- The structural wood lintel above the main entry opening is not sufficiently bearing on the brick walls. See **Photos 4.45, 4.47 & 4.50.**
- The concrete ramp leading to the main entry opening is beginning to spall. See **Photo 4.51.**

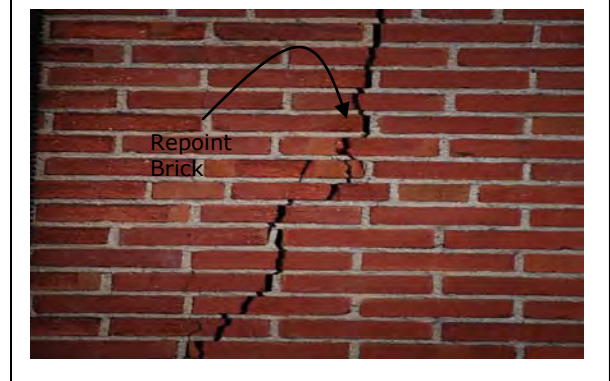
Photo 4.56

- Repointing of the brick is required between grids 1 and 2. See **Photo 4.62 & 4.63**.
- A sizeable crack and delamination exists in the brick near grid 4. See **Photos 4.54 – 4.58**.

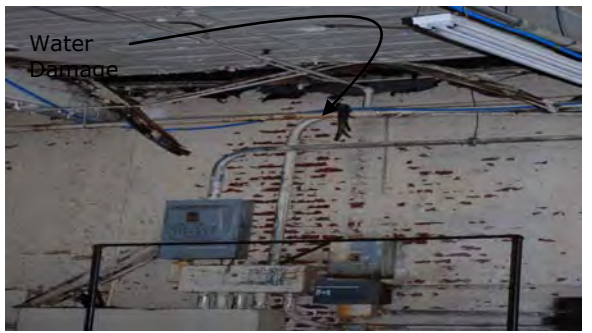
Area NO.7 (1915) Roof Framing  
Photo 5.87

Standing Water
