**STEWART**

RE: Grey Hosiery Mill Structural Assessment  
Hendersonville, NC

**PROJECT BACKGROUND AND DESCRIPTION**

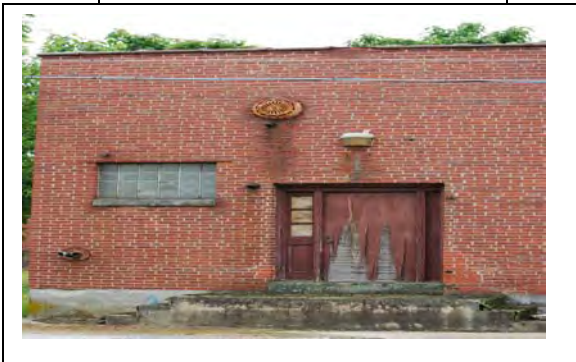
Photo 1.5

- Excessive growth of vegetation over the brick and concrete walls between grids Q and D. See **Photos 1.16 – 1.20**.
- A hole exists in the brick wall just above the stone masonry near grid I. See **Photos 1.17 & 1.19**.
- Significant concrete spalling has occurred at the concrete knee wall supporting the brick between grids D and C. See **Photos 1.12 & 1.13**.
- A section of brick has spalled at approximately fourteen brick courses above the door near grid C. See **Photo 1.14**.
- The steel lintels supporting the brick above the windows are rusted; this is typical for the five windows between grid D and the west end of the building. See **Photos 1.9, 1.10, & 1.15**.
- The wood door and wood door frame is starting to rot. Multiple glass panes are missing from the door frame. The steel lintel supporting the brick above the door is rusted. See **Photo 1.5**.

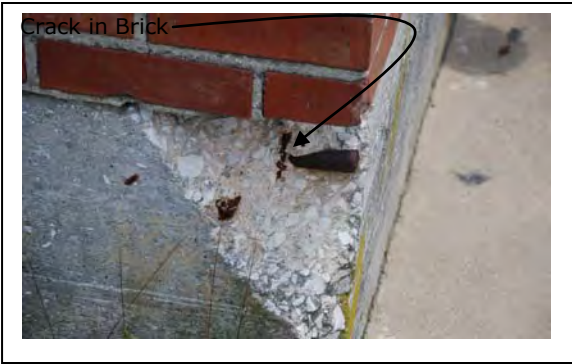
Photo 1.6

- Water staining was found in four locations between grid C and the west end of the building. See **Photos 1.8, & 1.11**.
- Repointing of the brick is required above the window near the west end of the building. See **Photo 1.7**.
- Significant concrete spalling has occurred at the concrete knee wall supporting the brick at the west end of the building. See **Photo 1.6**.

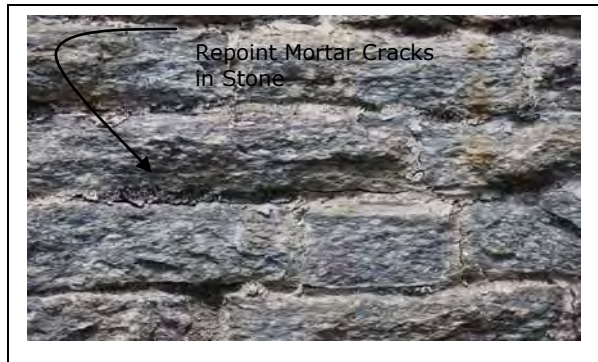
Photo 2.2

- Several cracks exist in the mortar joints of the stone masonry wall south of grid 13.5. See **Photo 2.2**.
- Two openings in the brick wall near grid 13.5, which serve as openings for mechanical equipment, do not appear to be sealed sufficiently for preventing water infiltration. See **Photos 2.5 and 2.6**.

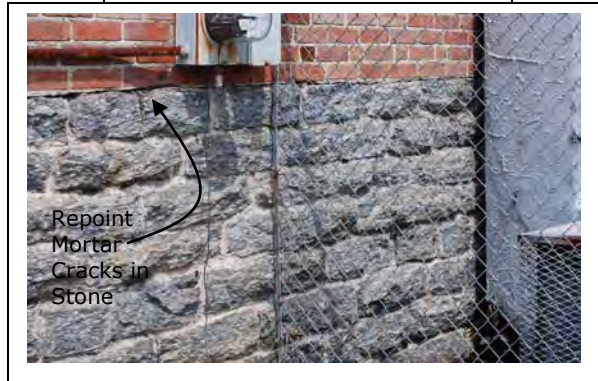
Photo 2.4

- Repointing of the stone masonry is required beside the smaller mechanical opening. See **Photo 2.4**.
- A crack exists in the mortar joints of the stone masonry wall between grids 13 and 12. See **Photos 2.9 & 2.10**.

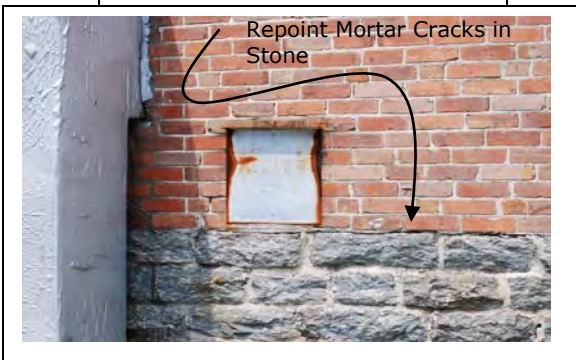
Photo 2.5

- Repointing of the brick is required just above the stone wall near grid 12. See **Photos 2.11 & 2.12**.
- Repointing of the stone masonry is required near grid 12. See **Photos 2.5, 2.7, & 2.8**.

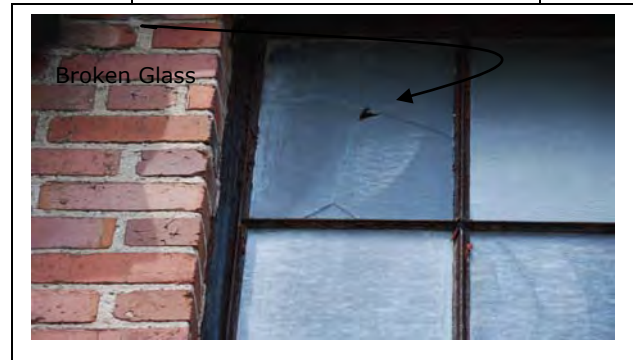
Photo 2.14

- A cracked window pane exists in the window frame on the front wall near grid 12. See **Photo 2.14**.
- A cracked window pane exists in the window frame on the back wall near grid 12. See **Photo 2.78**.

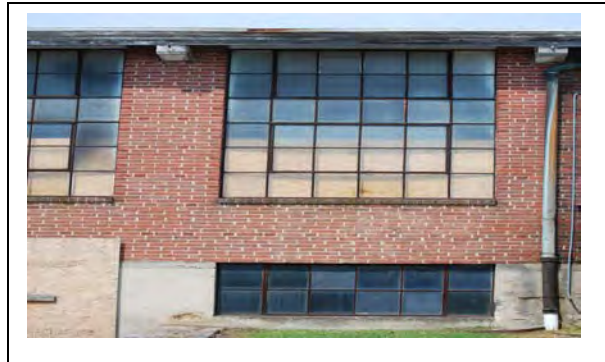
Photo 2.16

- Two cracked window panes exist in the window frame between grids 11.5 and 10.8. See **Photo 2.16 & 2.22**.
- Repointing of stone wall at ramp between grids 11.5 and 10.8 is required. See **Photo 2.19**.

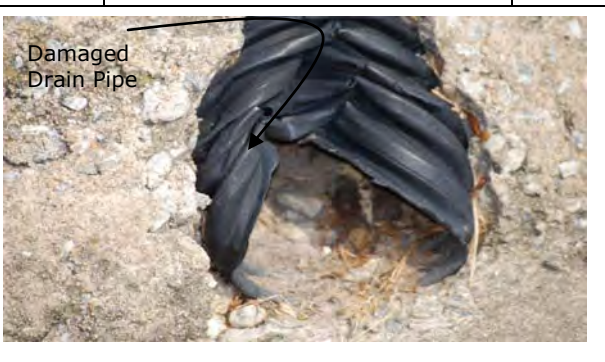
Photo 2.20

- The mouth of the drain pipe near the stone ramp has been damaged. See **Photo 2.20**.
- Plywood cover/infill has been installed in front of overhead door opening between grids 11.5 and 10.8. See **Photo 2.21**.

- Remove and replace drain pipe at Area 2 to match existing conditions. See **Photo 2.20**.
- At all existing openings that have been infilled/covered with plywood, as required by The Secretary of Interior's Standards for the Treatment of Historic Properties, the opening is to be restored to its originally intended use. Corrective waterproofing measures shall be taken during this restoration.

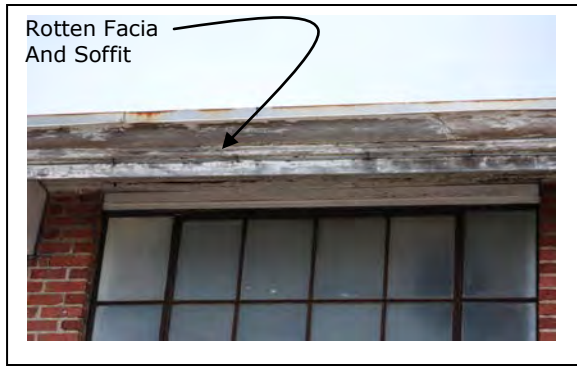
Photo 2.23

- Two window panes in the window frame near grid 7.5 have been infilled with ply wood. See **Photo 2.37**.
- The wood fascia at the roof along the entire perimeter has rotted. See **Photos 2.23 & 2.24**.

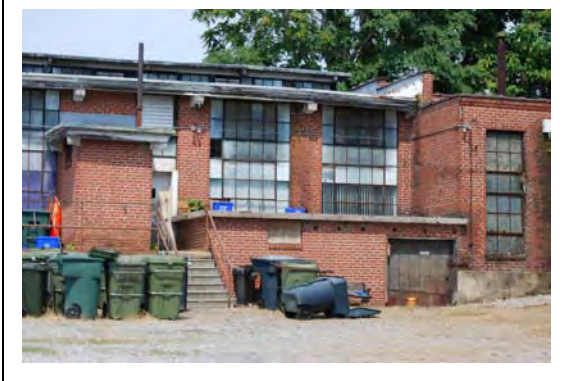
Photo 2.27

- A cracked window pane exists in the window frame between grids 6.4 and 5.9. See **Photo 2.27**.
- A crack exists in the mortar joints of the brick between the window frames near grid 5.9. See **Photo 2.58**.

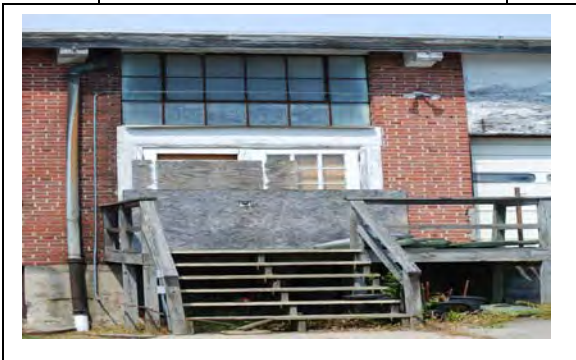
Photo 2.29

- Plywood cover/infill has been installed in front of the double door opening between grids 10.3 and 9.5. See **Photos 2.29 & 2.32**.
- A hole exists in the lower right corner of the overhead door between grids 9.5 and 8.3. See **Photos 2.35 & 2.36**.

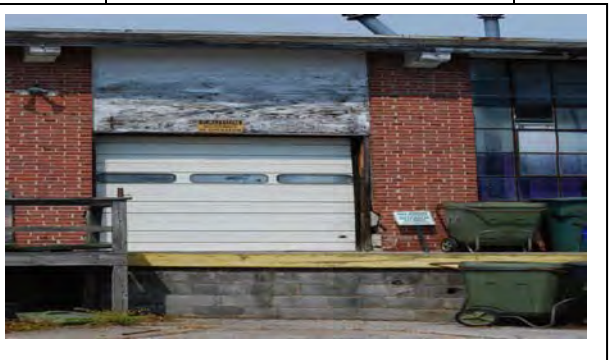
Photo 2.30

- Several bricks on each side of the overhead door at the loading dock have been broken. It appears a fix was conducted by way of concrete infill, but that has undergone damage as well. See **Photos 2.30 & 2.36**.

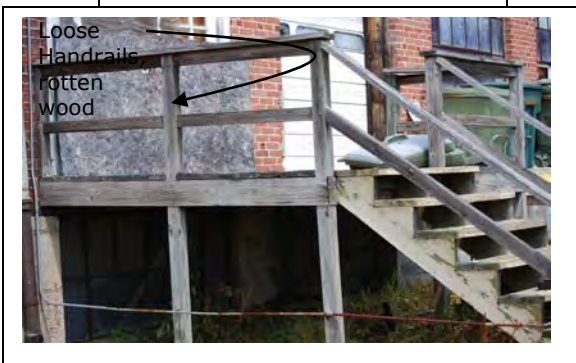
Photo 2.31

- The wooden deck that allows access to the double door entry between grids 10.3 and 9.5 is excessively worn and rotted, the handrails are loose, and several rusted nails are exposed. To be functional, the deck would need to be replaced in its entirety. See **Photos 2.31, 2.33, & 2.34**.

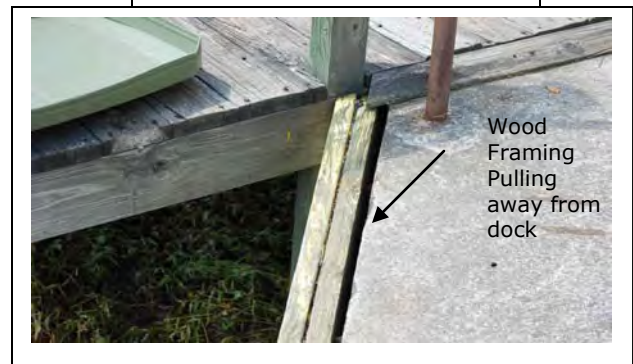
Photo 2.38

- Wood fascia at loading dock near grid 9.5 has pulled away from concrete slab creating a substantial gap. See **Photo 2.38 & 2.39**.

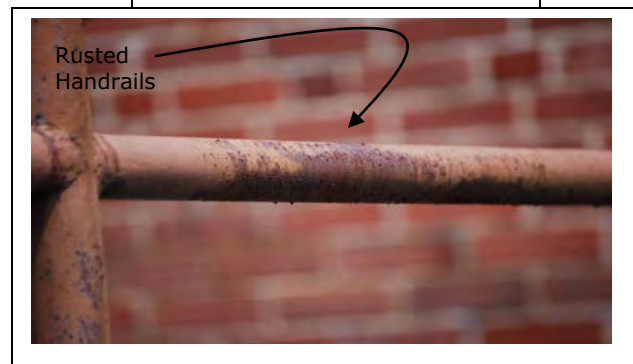
Photo 2.40

- The steel pipe railing that borders the loading dock has rusted. See **Photo 2.40**.
- Repointing of brick is required just above the loading dock near the single door entry. See **Photo 2.47**.

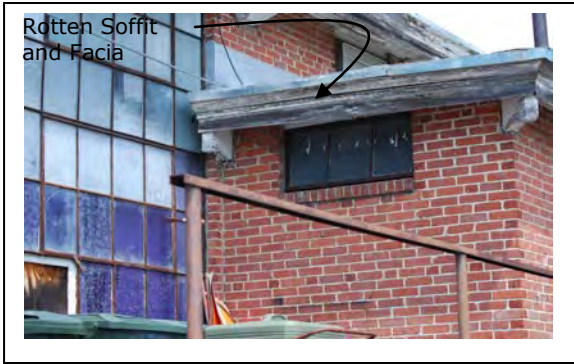
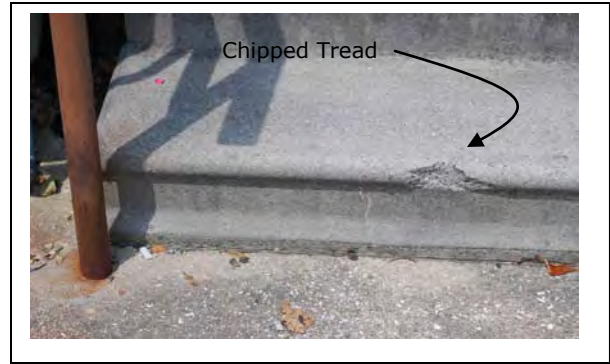
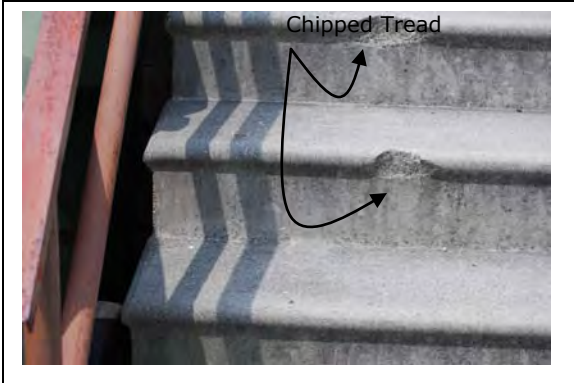
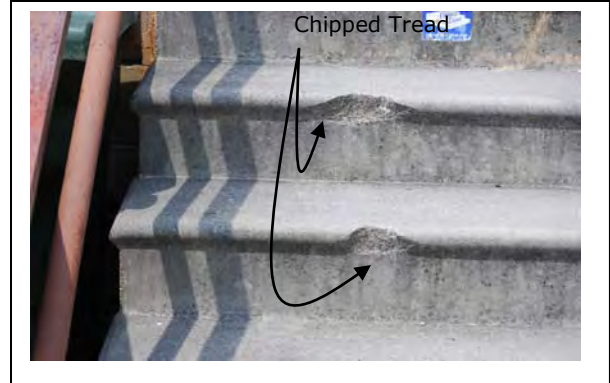
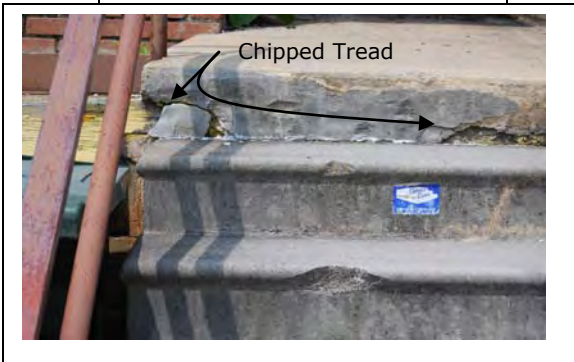
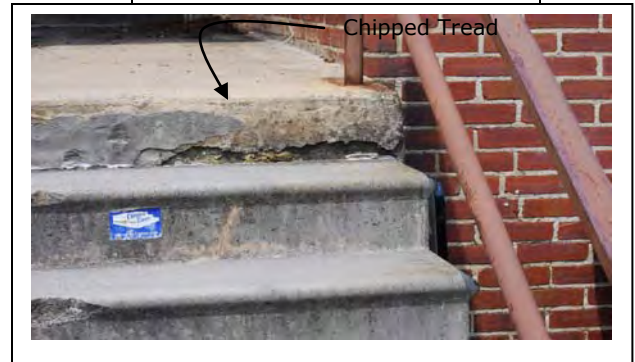
- Several of the concrete steps leading to the single door entry have chipped. See **Photos 2.41 – 2.46 & 2.54**.
- The concrete steps leading to the single door entry have pulled away from the concrete slab. See **Photo 2.55**.

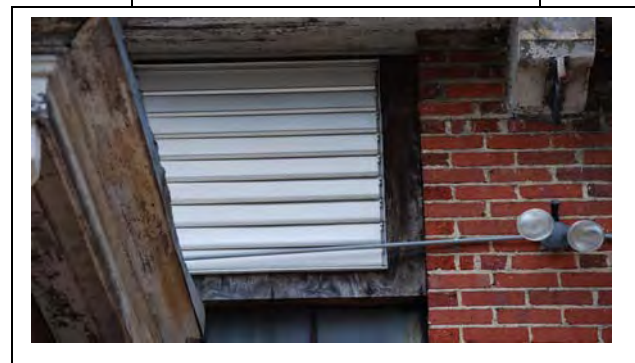
Photo 2.48

- The wood flashing for the louver opening above the single door entry has rotted. See **Photo 2.48**.
- A hole exists in the brick near the roof above the single door entry. See **Photos 2.51 & 2.52**.

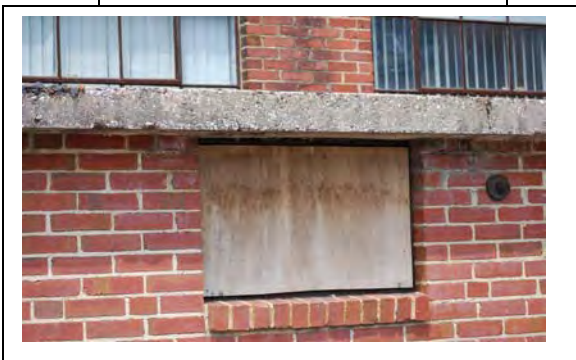
Photo 2.53

- A hole exists in the brick to the right of the concrete steps leading to the single door entry. See **Photo 2.62**.
- The opening in the lower front wall between grids 6.4 and 5.9 has been covered/infilled with plywood. See **Photo 2.53**.

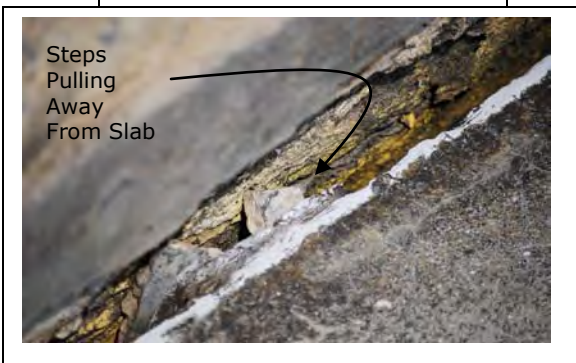
Photo 2.55

- The downspout between the two window frames near grid 5.9 does not continue all the way to the ground. See **Photo 2.57**.
- Concrete spalling has occurred in several locations at the low roof between grids 6.4 and 5.5. See **Photos 2.55 & 2.56**.

- See **Photos 2.63 – 2.72** at Area 4
  - Remove entire tree from inside brick wall down to foundations
  - Remove and replace brick wall to match existing conditions
- Replace all broken window panes or cover windows with plywood
- At all locations noted with holes in brick, infill with brick to match existing conditions
- Remove and replace all rotted wood windows and doors to match existing conditions
- Remove and replace any rotten wood members to match existing conditions at the south canopy
- At Area 2, all wood steps, handrails, and landings to be replaced. See **Photos 2.31, 2.33, & 2.34.**
- See **Photos 2.38 and 2.39**
  - Remove and replace rotten wood
- See **Photo 2.55**
  - Grout void between concrete steps and landing

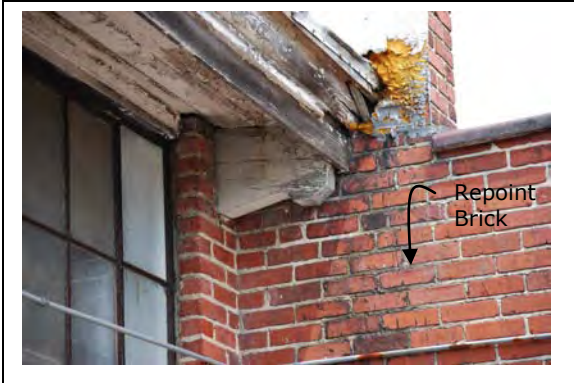
Photo 2.59

- The wood door frame for the low door between grids 5.9 and 5.5 has rotted. See **Photos 2.73 – 2.76**.
- The foam roof membrane at the high roof near grid 5.5 has rotted or disintegrated. Repointing of the brick is also needed in this area. See **Photos 2.59 & 2.60**.

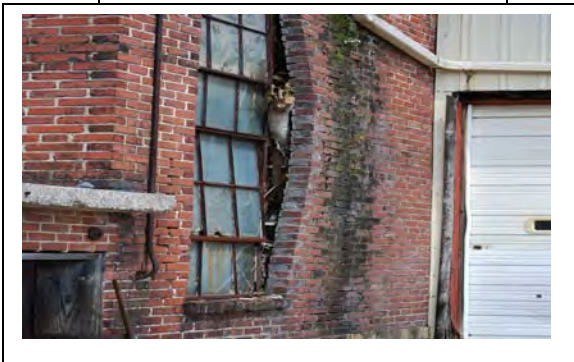
Photo 2.63

- The brick wall near grid 5.5 is bowed out and is missing mortar due to a sizeable tree that has grown in behind the brick. The tree has forced its way between the brick and adjacent window frame. See **Photos 2.63 – 2.72**.

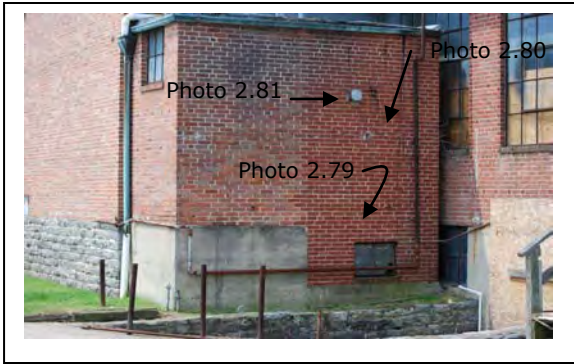
Photo 2.78

- Several holes exist in the brick in addition to a broken window pane and repointing of brick required at the north-facing bump-out wall between grid 12 and 11.5. See **Photos 2.78 - 2.81**.

- Replace all broken window panes or cover windows with plywood
- At all locations noted with holes in brick, infill with brick to match existing conditions
- Remove and replace all rotten wood windows and doors to match existing conditions
- Remove and replace any rotten wood members to match existing conditions at the south canopy. See **Photo 3.1**
- Infill jambs of west entry with brick to match existing. See **Photos 4.45 – 4.53**. The infill brick must extend to the underside of roof beam to provide beam bearing support.
- See **Photo 4.82 – 4.85**
  - Remove and replace rotten plywood
  - Repair cracked concrete as follows:
    - Repair with SikaGrout 328, apply per the manufacturer's instructions

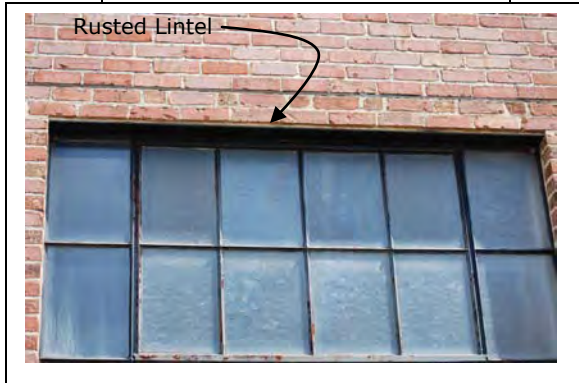
Photo 3.3

- Four cracked window panes exist in the steel window frame west of grid B. See **Photo 3.4**.
- At the window openings on each side of grid B, the steel lintels have rusted. See **Photo 3.3**.
- The wood canopy at the first entry from the left has rotted. See **Photo 3.7**.
- A chipped stair tread exists at the top of the concrete steps leading to the first entry. See **Photo 3.5**.

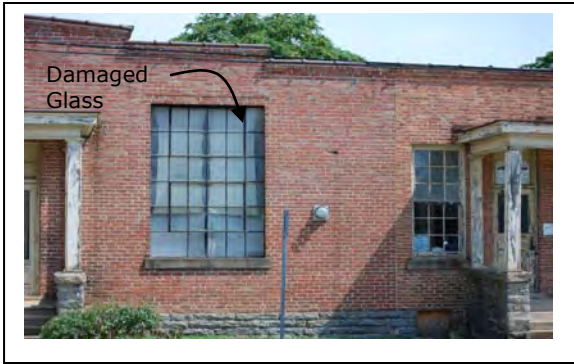
Photo 3.7

- Four (4) cracked window panes exist in the steel window frame just east of grid B. See **Photo 3.8**.
- A hole exists in the brick between grids B and C. See **Photo 3.7**.

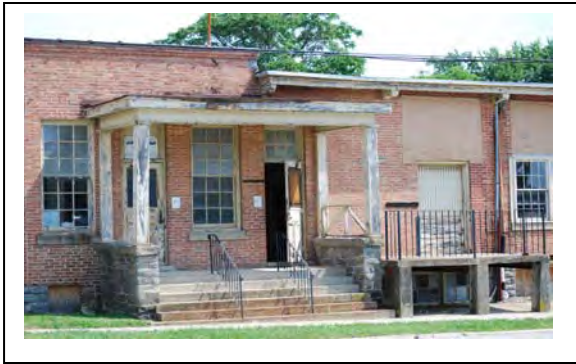
Photo 3.9

- The wood window frame and the wood door near grid C have rotted. See **Photo 3.9**.
- The window above the door near grid C has been covered/infilled with plywood. See **Photo 3.9**.

- Cracking/chipping has occurred in the precast door sill at the left side of the main entry. See **Photo 3.13**.
- At the window located between the two single doors of the main entry, a cracked window pane exists in the window frame, the wood window frame has rotted, and the right corner of the precast window sill is chipped. See **Photo 3.9**.

- Several cracks exist in the precast door sill at the right side of the main entry. See **Photo 3.20**.
- The wood handrail and roof fascia of the main entry canopy have rotted. See **Photo 3.9, 3.21, & 3.22**.

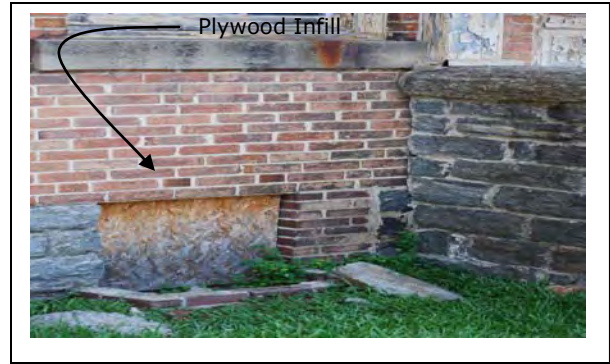
Photo 3.10

- The lower wall opening between grid C and D has been covered/infilled with plywood. See **Photo 3.10**.
- Several of the concrete steps leading to the main entry have chipped. See **Photos 3.12 – 3.18**.

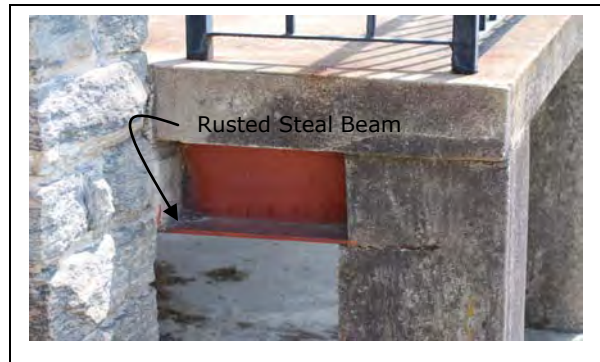
Photo 3.24

- The W8 beams supporting the loading dock slab are rusted. See **Photo 3.24, 3.28, & 3.30**.
- The wood door and door frame at the loading dock entry is rotted. See **Photo 3.35**.

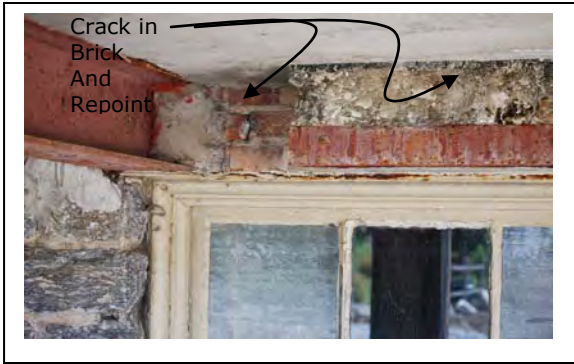
Photo 3.31

- The loading dock slab is supported by (3) W8 steel beams. Where the W8 located in the center of the slab meets the stone wall, the beam bearing position is directly over top of the opening (see **Photo 3.31**) rather than the jamb of the opening (see **Photo 3.32**).

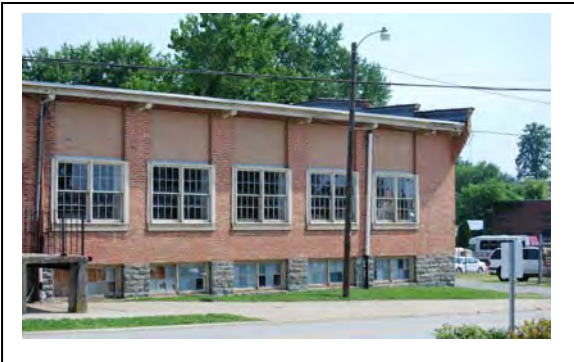
Photo 3.37

- The downspout to the right of the loading dock is disconnected before it reaches the ground. See **Photo 3.38**.
- The opening above each high window frame from the loading dock to grid H has been infilled with brick. See **Photo 3.37**.

- The steel lintels at each high window opening from the loading dock to grid H have rusted. See **Photos 3.42-3.44, & 3.47**.
- Nine window panes are missing from the low window frame nearest the loading dock. The opening has been covered/infilled with plywood. See **Photo 3.37**.

- Four window panes are missing from the low window frame nearest grid D. Two holes have been cut in another window pane to allow for PVC pipe penetrations. See **Photo 3.37**.

- One window pane in the window frame between grids F and H has been replaced with a dryer vent. See **Photo 3.37**.
- Several cracks exist in the precast sills of each high window frame from the loading dock to grid H. See **Photos 3.39 – 3.41, 3.45, & 3.46**.

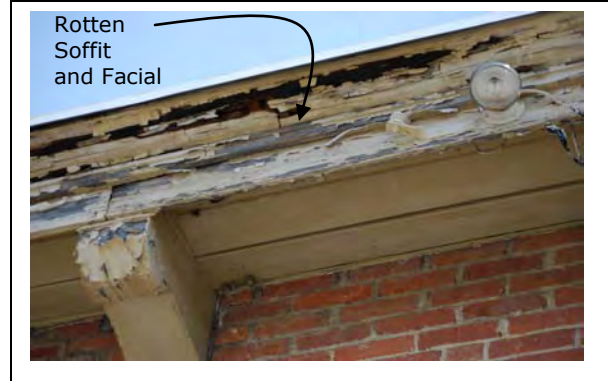
Photo 3.48

- Mortar is missing in the stone wall nearest grid H. See **Photo 3.52**.
- The wood fascia along the roof between the main entry and grid H is rotten. See **Photo 3.48**.

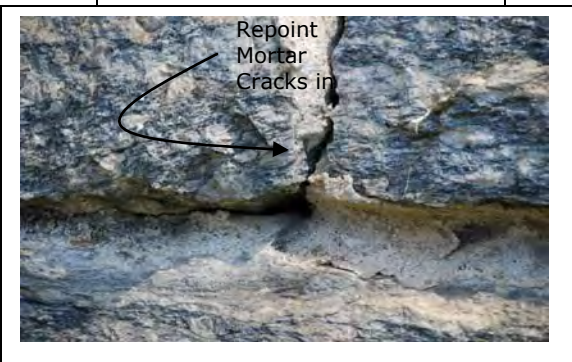
Photo 3.49

- Mortar is missing in the stone wall between grids D and E. See **Photo 3.49**.
- Mortar is missing in the stone wall between grids E and F. See **Photo 3.51**.

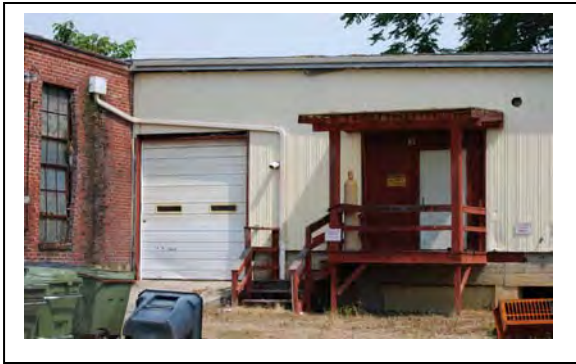
Photo 3.53

- A hole exists in the aluminum siding between grids H and I. See **Photo 3.58**.
- A hole has been cut in the aluminum siding between grids H and I to allow for PVC pipe penetration. See **Photo 3.53**.

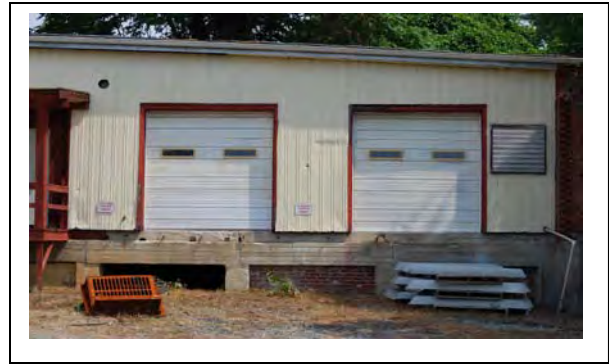
Photo 3.54

- The wood stairs and deck at the entry near grid I are rotten and worn, and the handrails have become loose. See **Photos 3.59 – 3.61**.
- The aluminum siding has been significantly damaged in two locations between grids I and J. See **Photos 3.54, 3.58, 3.64, & 3.65**.

- A hole exists in the aluminum siding between grids I and J. See **Photos 3.66 & 3.68**.
- Brick infill is missing between the concrete piers that are located between grids J and K. See **Photo 3.54**.

- Chipping of the concrete slab has occurred between grids J and K. See **Photos 3.54, 3.71 – 3.73**.
- A crack exists in the concrete beam between grids J and K. See **Photo 3.54**.

- The aluminum siding has been significantly damaged in two locations between grids J and K. See **Photo 3.54**.
- Aluminum panel soffit is missing from grid H to just past grid J. See **Photos 3.54, 3.62, 3.63, 3.67, & 3.68**.

- Several anchor bolts have projected past the edge of the concrete slab from grid J to the end of the building. See **Photos 3.54, 3.71 – 3.73**.
- An opening exists in aluminum siding for mechanical louver. See **Photo 3.69**.

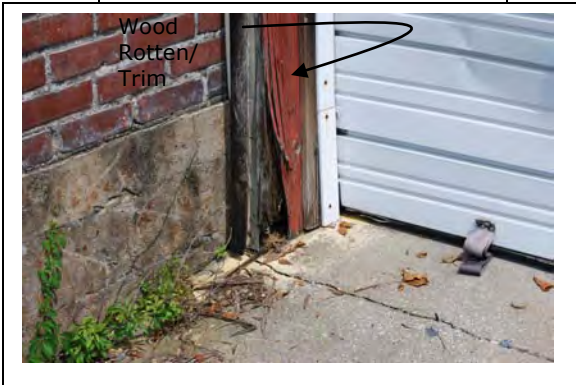
Photo 3.55

- A crack exists in the concrete ramp leading to the overhead door between grid H and I. See **Photo 3.55**.
- The wood fascia around the overhead door between grid H and I has rotted. See **Photos 3.55 – 3.57**.

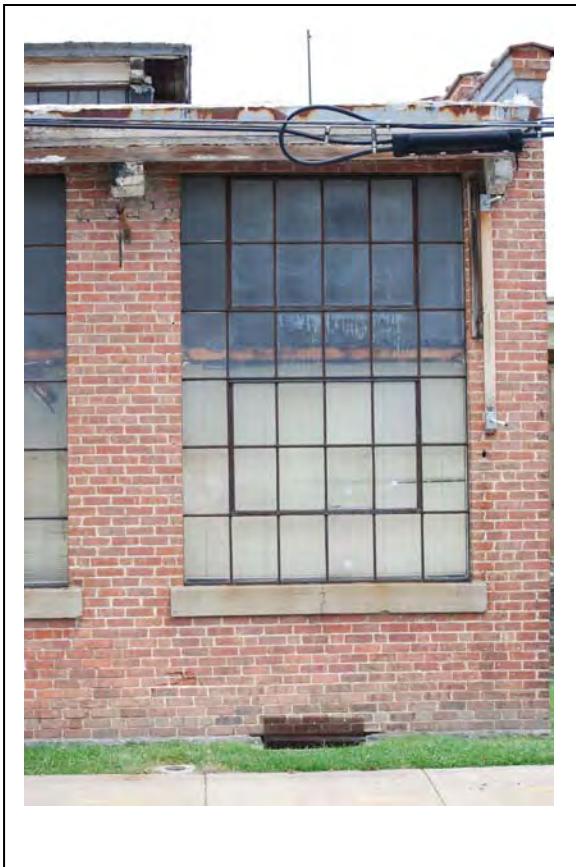
Photo 4.1

- Two (2) cracked window panes exist in the window frame near grid 14. See **Photo 4.1**.
- A crack exists in the precast concrete sill near grid 14. See **Photo 4.72**.

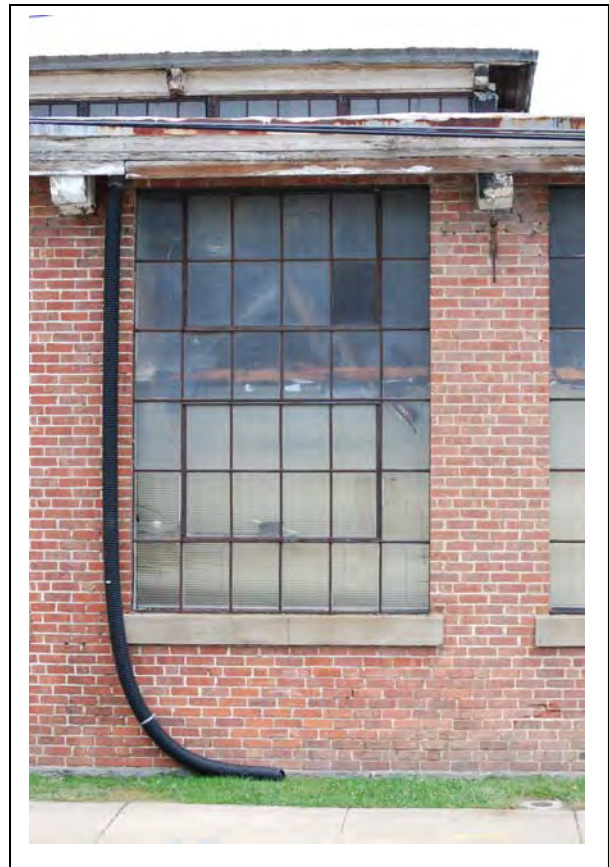
Photo 4.2

- Four (4) cracked window panes exist in the window frame between grids 13 and 14. See **Photo 4.2**.
- A crack exists in the precast concrete sill between grids 13 and 14. See **Photo 4.73**.

- Repointing of the brick is required below the window between grids 13 and 14. See **Photo 4.2**.
- The wood soffit is missing above the window between grids 13 and 14. See **Photo 4.78**.

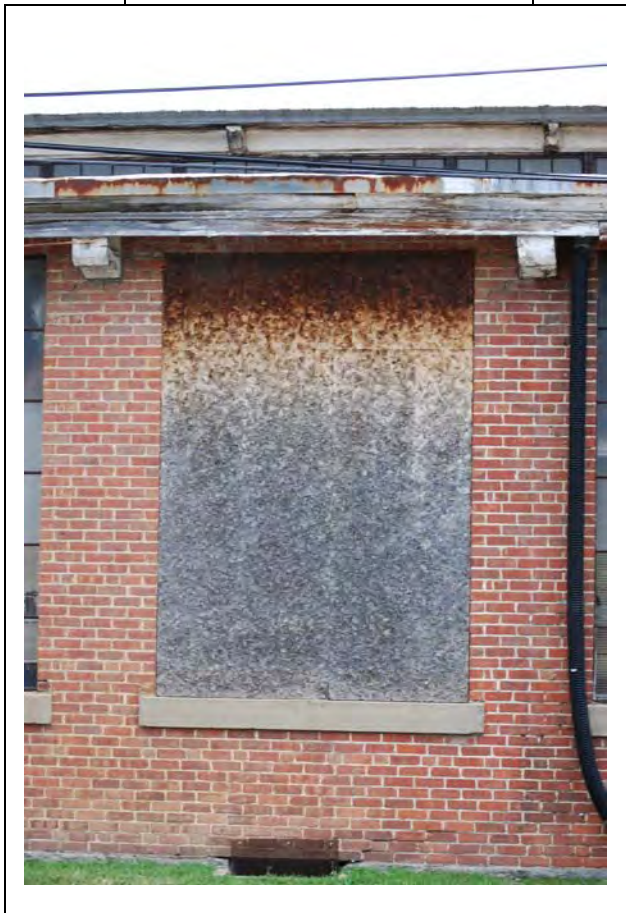
Photo 4.3

- A crack exists in the precast concrete sill between grids 12 and 13. See **Photo 4.77**.
- The window opening near grid 13 has been covered/infilled with plywood. See **Photo 4.3**.

- A crack exists in the precast concrete sill near grid 13. See **Photo 4.80**.
- Repointing of the brick is required below the window near grid 13. See **Photo 4.3**.

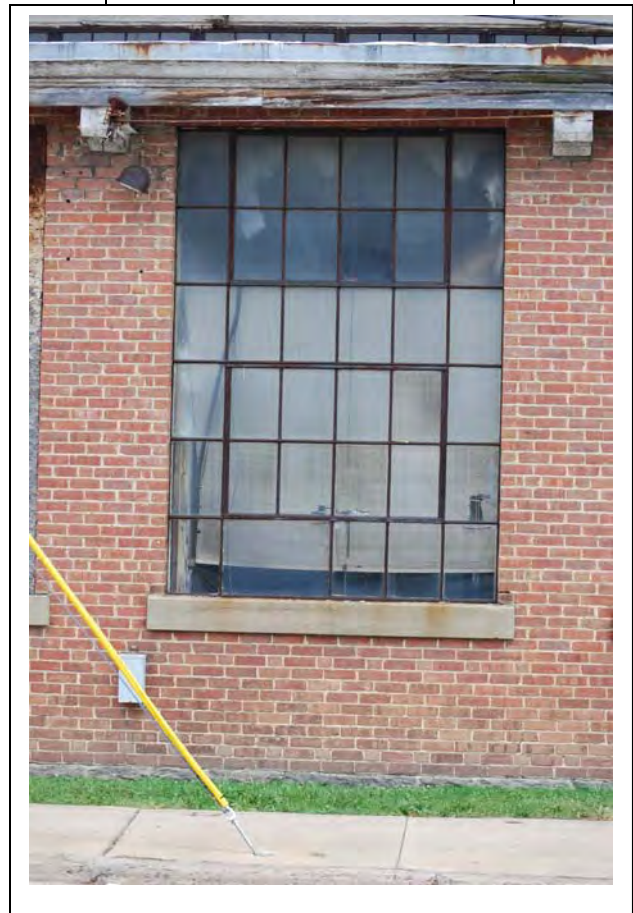
Photo 4.4

- Repointing of the brick is required in the wall near grid 12. See **Photo 4.4**.
- A cracked window pane exists in the window frame between grids 12 and 13. See **Photo 4.4**.

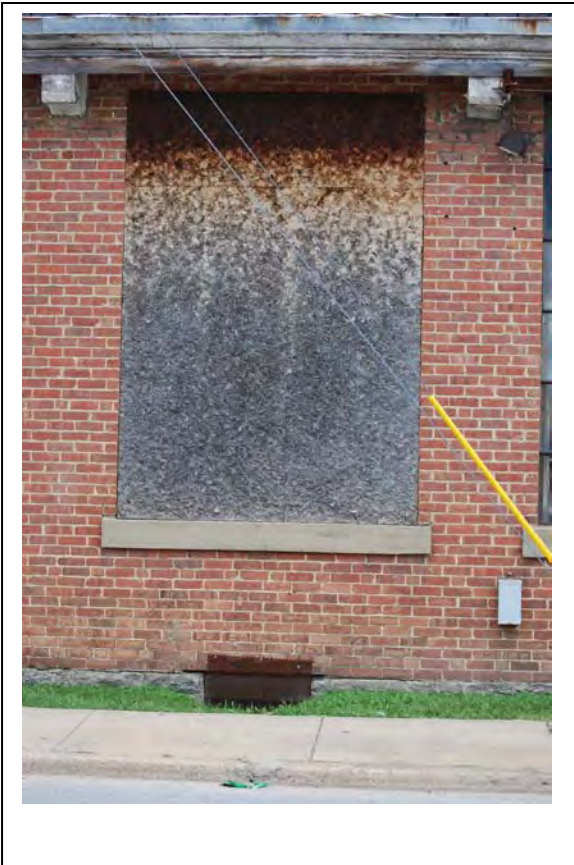
Photo 4.5

- A crack exists in the precast concrete sill nearest grid 11. See **Photo 4.29**.
- The window opening between grids 11 and 12 has been covered/infilled with plywood. See **Photo 4.5**.

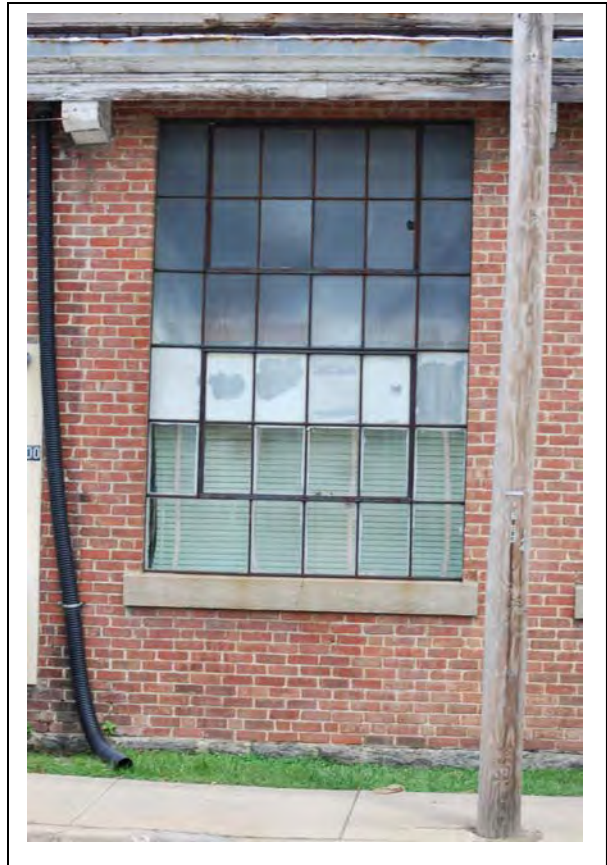
Photo 4.6

- The downspout near grid 11 feeds directly onto the sidewalk. See **Photo 4.6**.
- A cracked window pane exists in the window frame. See **Photo 4.6**.

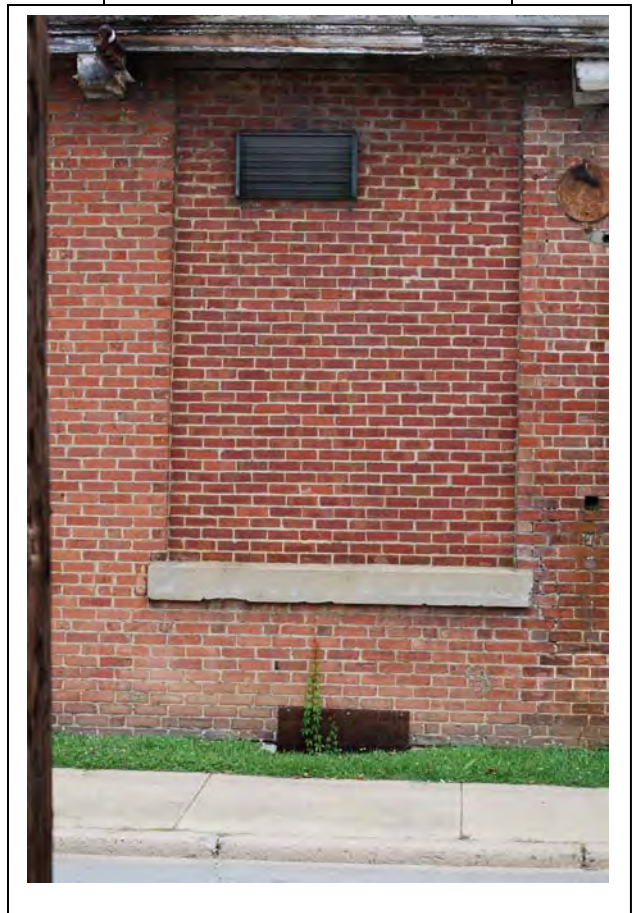
Photo 4.8

- A louver opening exists at the top of the brick infill between grids 8 and 9. See **Photo 4.8.**
- A hole in the brick wall exists near grid 9 for a pipe penetration. See **Photo 4.34.**

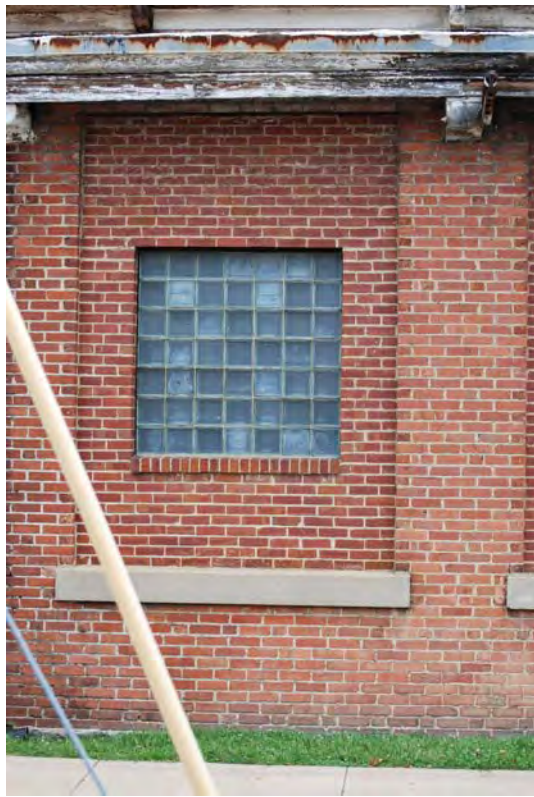
Photo 4.9

- The downspout between grids 7 and 8 is situated on the ground in a way that permits water to flow back towards the building. See **Photo 4.17.**
- Repointing of the brick is required above the opening near grid 8. See **Photo 4.9.**

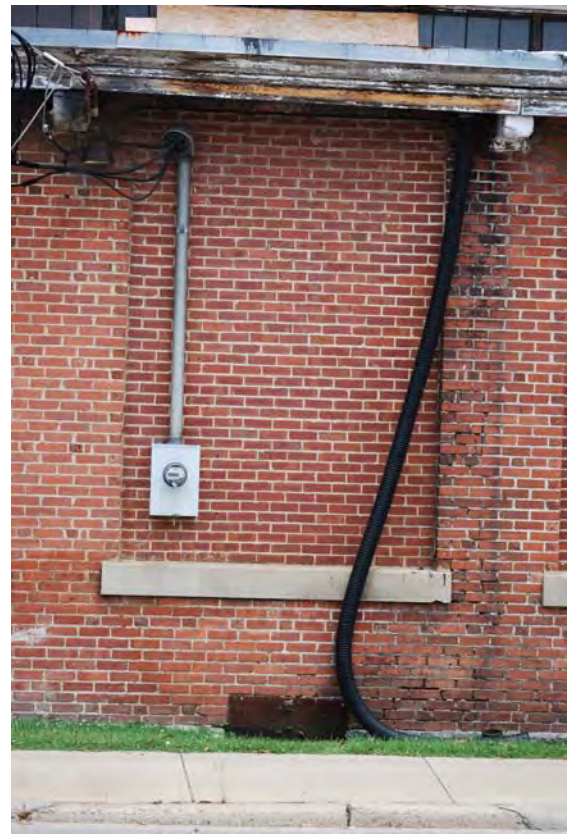
Photo 4.10

- A crack exists in the precast concrete sill below the window between grids 6 and 7. See **Photo 4.28.**
- Repointing of the brick is required at the top and bottom of the wall between grid 7 and 8. See **Photos 4.10, 4.18, 4.19, & 4.24.**

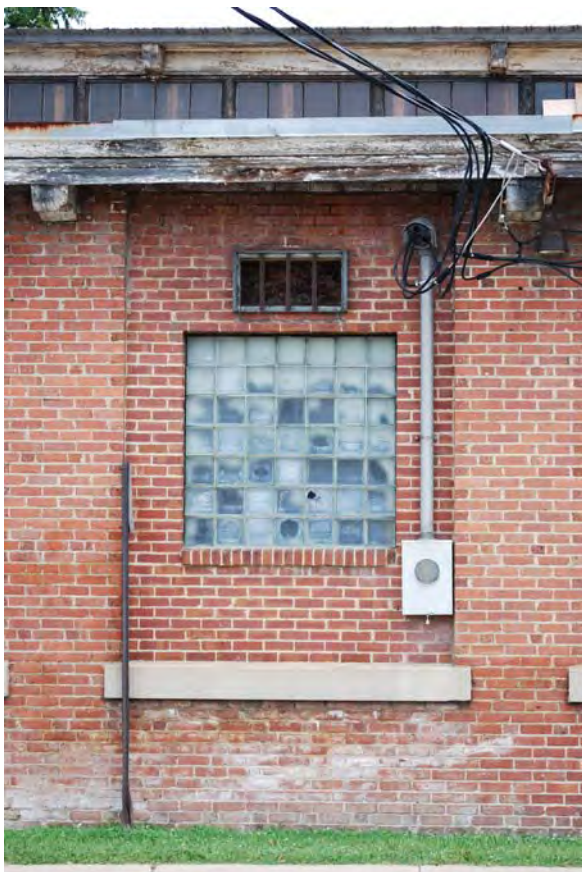
Photo 4.11

- Chipping of concrete has occurred at the small concrete areaway near grids 6, 8, and 9. See **Photo 4.44, 4.27, & 4.36** respectively.
- Cracking exists in one of the glass masonry units in the opening between grids 6 and 7. See **Photo 4.11.**

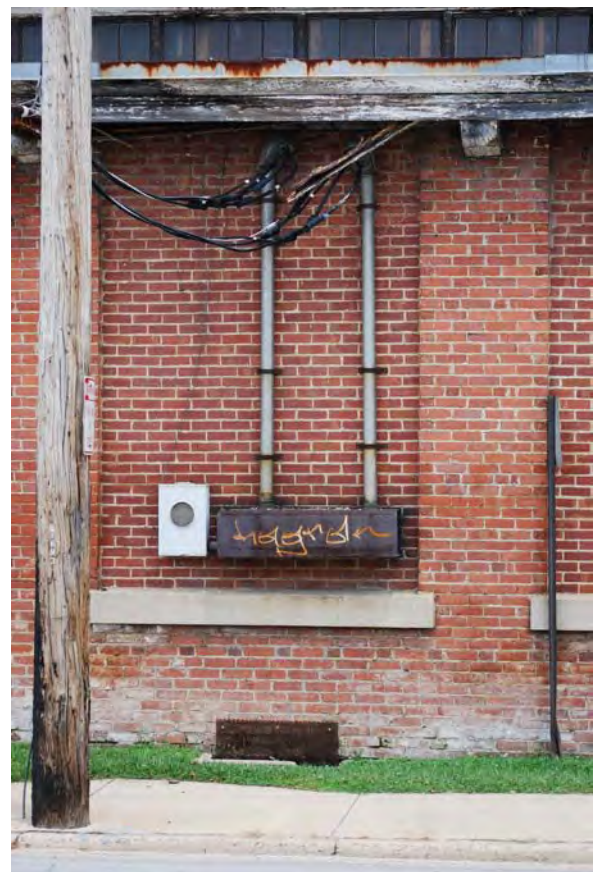
Photo 4.12

- Repointing of the brick is required in the brick infill near grid 6. See **Photo 4.12, 4.37, & 4.38.**
- The wood soffit above the brick infill near grid 6 is missing. See **Photo 4.12.**

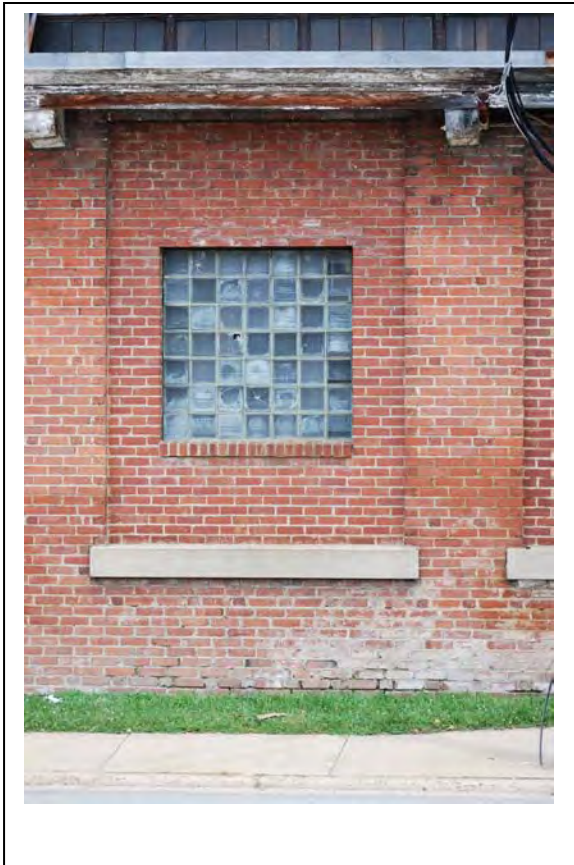
Photo 4.13

- Cracking exists in seven glass masonry units in the second opening between grids 5 and 6. See **Photo 4.13.**
- Repointing of the brick is required above and below the second opening between grids 5 and 6. See **Photos 4.13 & 4.42.**

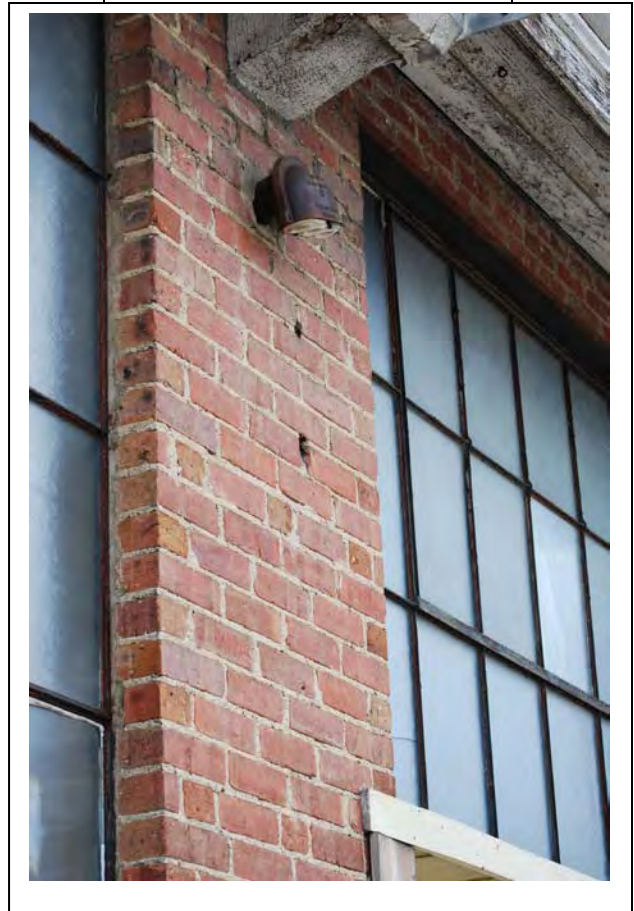
Photo 4.16

- Five cracked window panes exist in the window frame between grids 9 and 10. See **Photo 4.30**.
- Two holes exist in the brick wall near grid 10 for lighting conduit. See **Photo 4.16**.

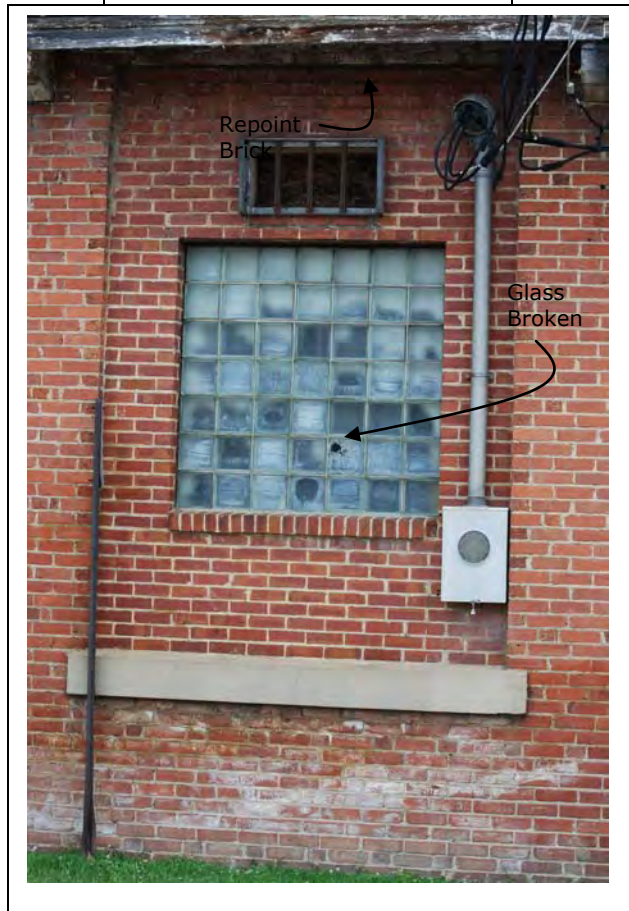
Photo 4.20

- A louver opening exists above the window between grids 6 and 7 and has been infilled with plywood. See **Photo 4.43.**
- A brick at the lower right corner of the window between grids 6 and 7 is significantly chipped. See **Photo 4.20.**

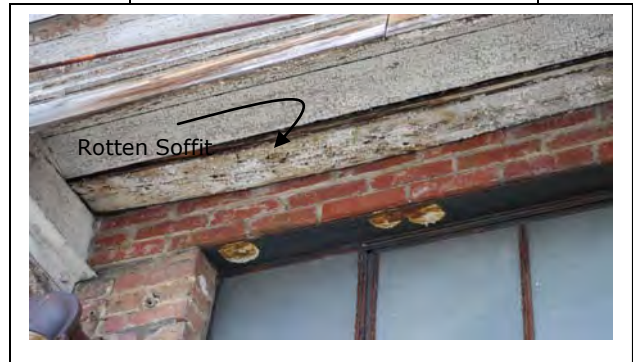
Photo 4.26

- A crack exists in the precast concrete sill. See **Photo 4.81**.
- The steel lintels above all steel window frames have rusted. See **Photos 4.26, 4.37, 4.38, & 4.42**.

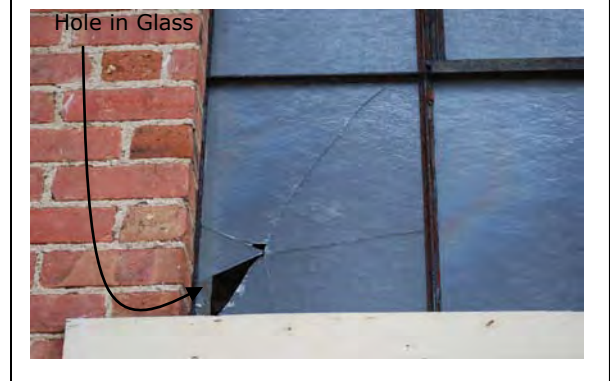
Photo 4.32

- A crack exists in the precast concrete sill below the window between grids 9 and 10. See **Photo 4.35**.
- A cracked window pane exists in the window frame between grids 10 and 11. See **Photo 4.32**.

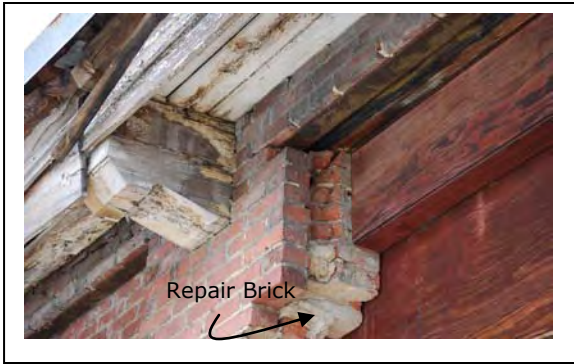
Photo 4.45

- Missing bricks and severe cracks exist on each side of the main entry opening between grids 4 and 5. See **Photos 4.45 – 4.53.**
- The main entry opening has been infilled with plywood. See **Photos 4.45 – 4.53.**

- The structural wood lintel above the main entry opening is not sufficiently bearing on the brick walls. See **Photos 4.45, 4.47 & 4.50.**
- The concrete ramp leading to the main entry opening is beginning to spall. See **Photo 4.51.**

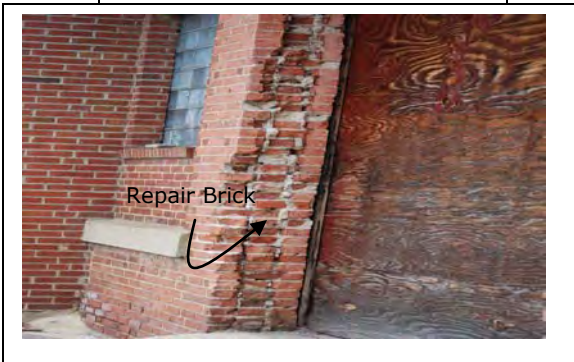
Photo 4.49

- Six cracked window panes exist in the window frame near grid 4. See **Photo 4.49 & 4.54**.

- Repointing of the brick is required above and below the window nearest grid 4. See **Photo 4.49 & 4.50.**
- The wood soffit above the window nearest grid 4 is missing. See **Photo 4.50.**

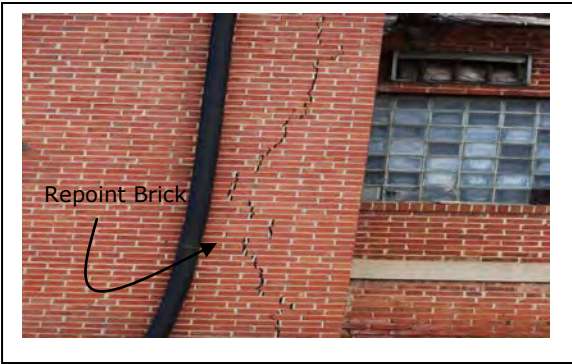
Photo 4.54

- Repointing of the brick is required between grids 1 and 2. See **Photo 4.62 & 4.63**.
- A sizeable crack and delamination exists in the brick near grid 4. See **Photos 4.54 – 4.58**.

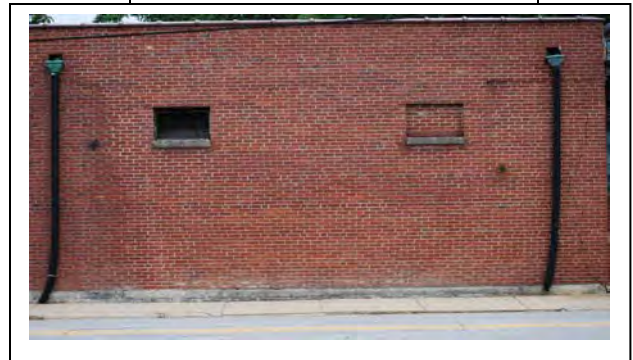
Photo 4.59

- The first louver opening between grids 3 and 4 has been infilled with plywood. The second louver opening between grids 3 and 4 has been infilled with brick. See **Photo 4.59**.

- The downspouts near grids 1, 2, 3, & 4 terminate directly at the sidewalk. Efflorescence exists on the brick wall at each location of the downspouts. See **Photos 4.59 – 4.64**.

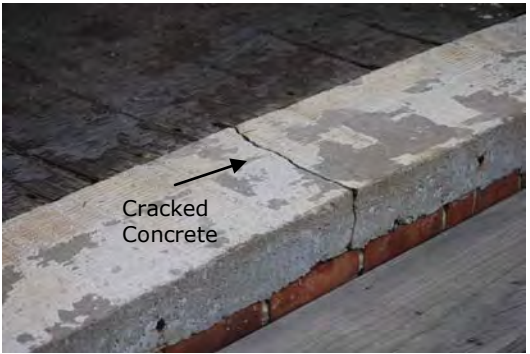
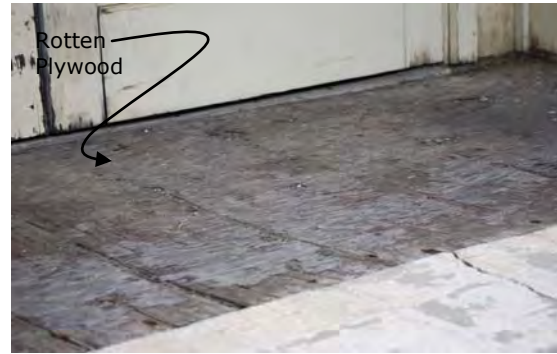
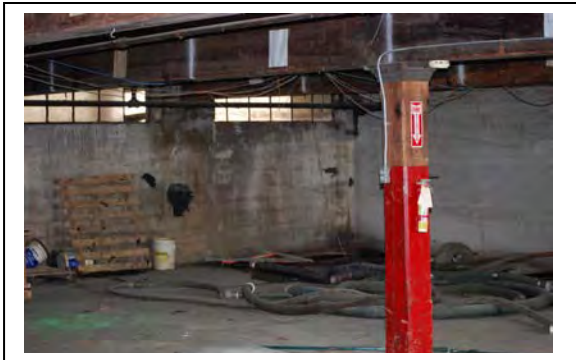
- The plywood flooring at the entry between grids 10 and 11 has rotted, the wooden steps and handrails lack stability, and a crack exists in the top concrete step leading to the entry. See **Photos 4.83 – 4.85**.
