**STEWART**

RE: Grey Hosiery Mill Structural Assessment  
Hendersonville, NC

**PROJECT BACKGROUND AND DESCRIPTION**

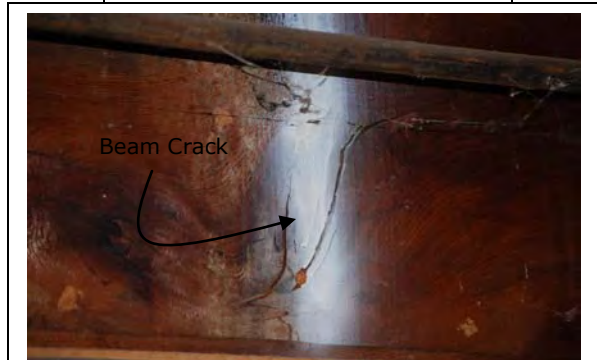
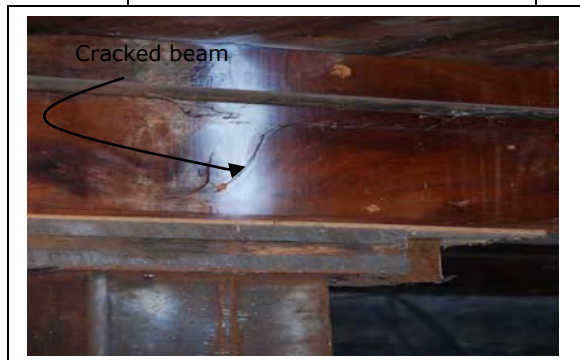
- A crack exists in a wood beam. See **Photos 5.4 & 5.5.**
- Repointing of the stone masonry is required in the southwest corner of the partial basement. See **Photo 5.6.**
- Repointing of the brick is required at the northwest corner of the partial basement. Also, the steel lintel in this location is rusted. See **Photo 5.7.**
- A wood beam on grid 10.3 has suffered significant termite damage. See **Photo 5.8.**
- Water infiltration in the northwest corner of the partial basement has resulted in ponding at the basement slab on grade. See **Photos 5.9 & 5.10.**
- Chipping has occurred at a wood beam along grid 10.8. See **Photo 5.11.**
- A crack exists in the foundation wall at the east side of Area 2. See **Photo 5.12.**

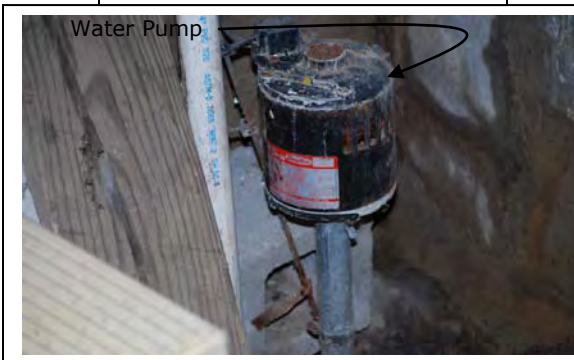
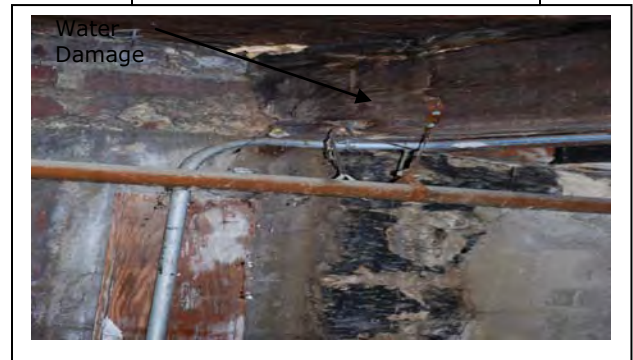
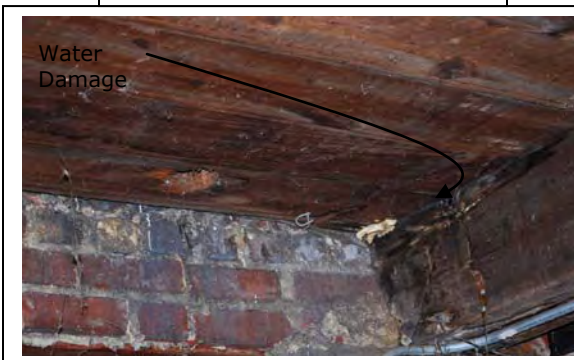
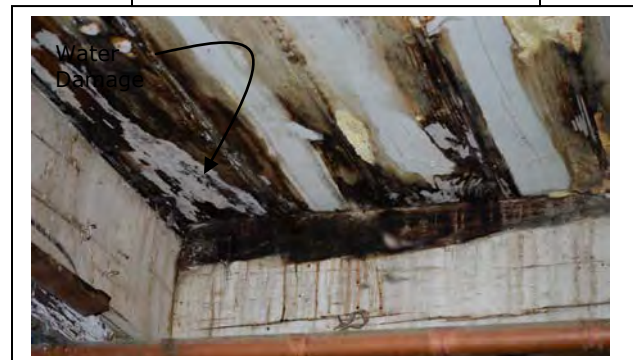
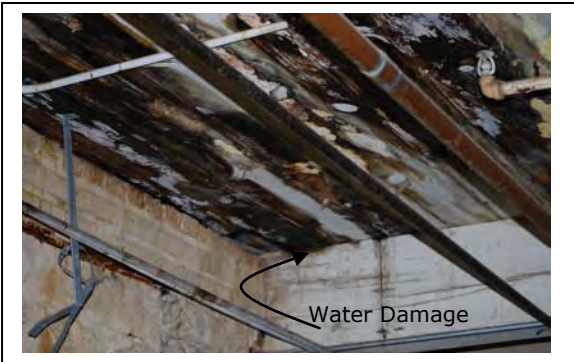
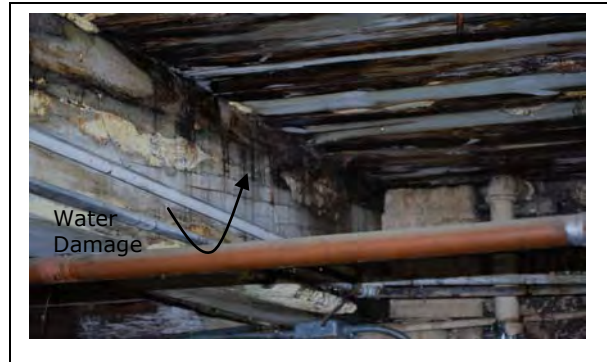
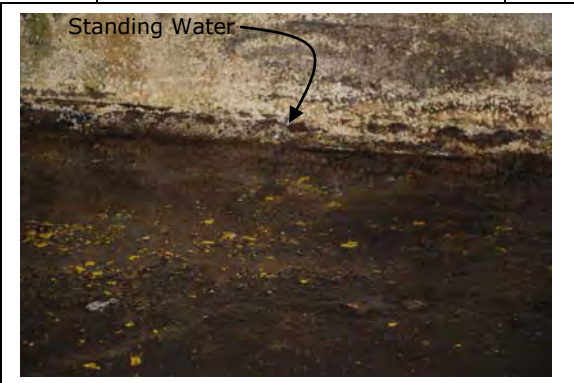
- Significant water infiltration in the northeast corner of Area 1 has resulted in ponding at the basement slab on grade and severe rotting of the 1<sup>st</sup> floor wood framing. See **Photos 5.13-5.19.**
- A sump hole exists in the southeast corner of Area 1. See **Photo 5.20.**
- A vertical crack exists in the south concrete basement wall. See **Photo 5.21.**
- A crack exists in a wood beam. See **Photo 5.22.**
- A crack exists in the foundation wall at the bearing location of the steel lintel. See **Photos 5.23 & 5.24.**
- (2)3x8 wood decking boards were used as the structural headers at each end of the stair. See **Photos 5.25 & 5.26.**
- A large portion of existing brick infill has been knocked out. See **Photo 5.27.**

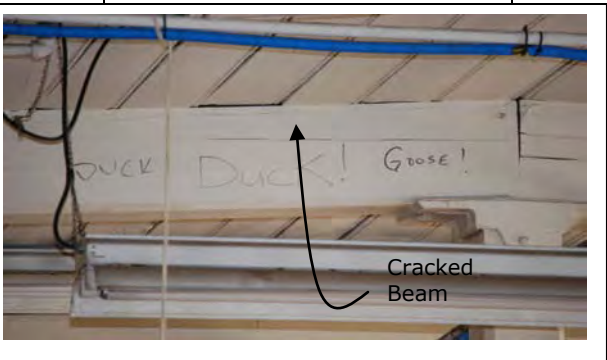
Area NO.1 (1919) Roof Framing  
Photo 5.30

- Cracks exist in several wood beams. See **Photos 5.30 & 5.31** as typical.
- Water damage has occurred in northeast corner of Area 1 and has caused the wood roof framing and the 1<sup>st</sup> floor finish to rot. See **Photos 5.32 – 5.38.**
- Water damage has occurred in the northeast vestibule of Area 1 and has caused the wood to warp and separate from the bearing walls. See **Photos 5.39 & 5.40.**

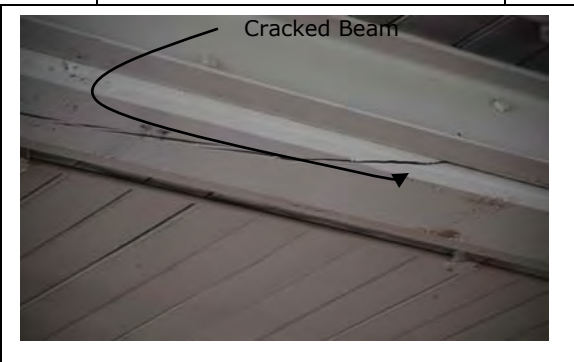
Area NO.2 (1919) Roof Framing  
Photo 5.45

- A cracked wood beam along grid 11.5 has been reinforced with (2)C10 channels. See **Photos 5.45 – 5.47.**
- Wood double door leading to courtyard has become warped and is in need of replacement. See **Photo 5.48.**

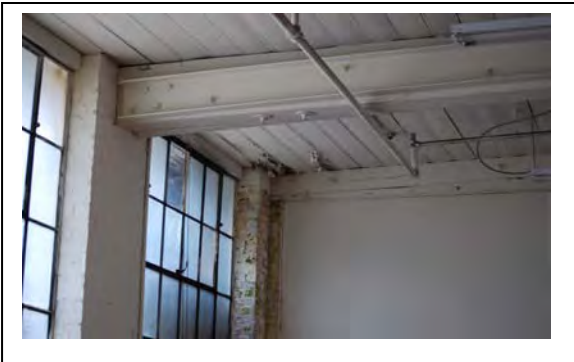
Area NO.2 (1919) Roof Framing  
Photo 5.49

- Water damage has occurred in the southeast corner of Area 2 and has caused the wood decking to rot. See **Photo 5.49**.
- Cracks exist in the slab on grade near grid 8.3. See **Photo 5.50**.
- Water damage has occurred in the northwest corner of Area 2 and has caused the wood beam and roof decking to rot. See **Photos 5.109 & 5.110**.

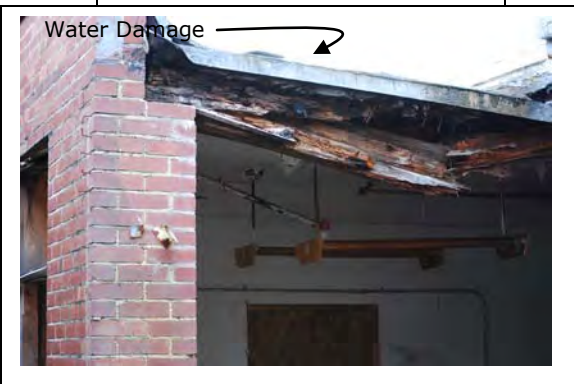
Area NO.6 (1915) Roof Framing  
Photo 5.51

- Severe water damage has occurred at the north end of Area 6 and has caused the complete decay and failure of the structural roof framing. See **Photo 5.51 & 5.58-5.60**.
- Severe water damage has occurred at the north end of Area 6 and has caused several areas of wood framing to rot. See **Photos 5.52-5.57**.
- Water damage has occurred near grid 13.5. See **Photos 5.75 & 5.76**.

- Remove and replace wood decking and framing to match existing at areas noted in the Observations section above.
- See **Photos 5.51 – 5.62** at courtyard vestibule
  - Remove and replace all wood framing to match existing conditions.

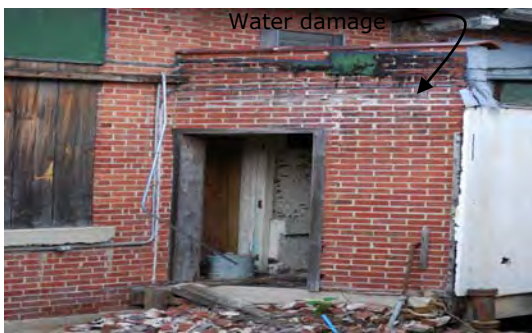
Area NO.7 (1915) Photo 5.61

- Water damage has occurred at the north end of the courtyard and has caused the wood roof framing to rot, deterioration of the brick mortar joints, and cracks in the concrete wall. See **Photos 5.61 & 5.62.**

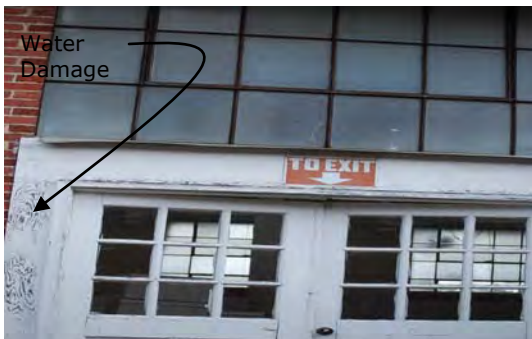
Area NO.7 (1915) Taken From  
Courtyard Photo 5.63

- Water damage has occurred at the east wall of the courtyard. The wood double door frame and the four (4) window frames north of the double door have all rotted. See **Photos 5.63 – 5.67.**

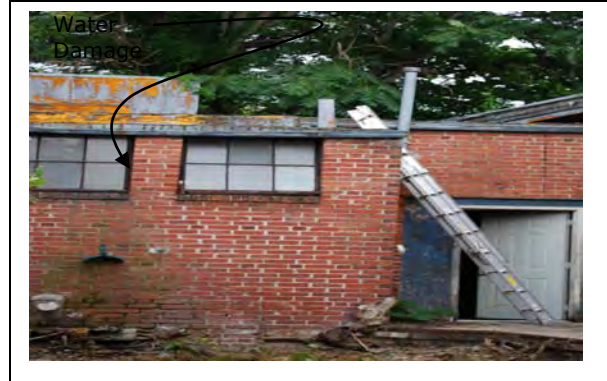
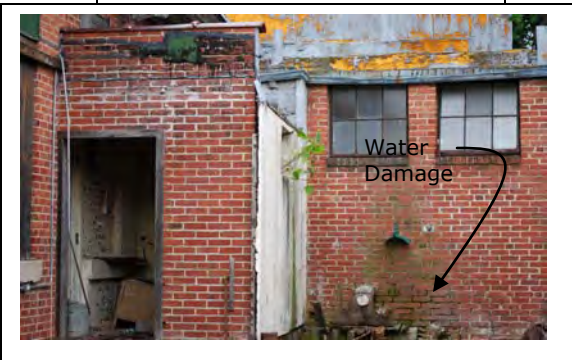
- Water damage has occurred at the north wall of the courtyard and has caused the brick mortar to deteriorate. See **Photos 5.68 & 5.69.**
- A crack exists in the concrete slab on grade located in the corridor that connects Area 2 and Area 7. See **Photo 5.111.**

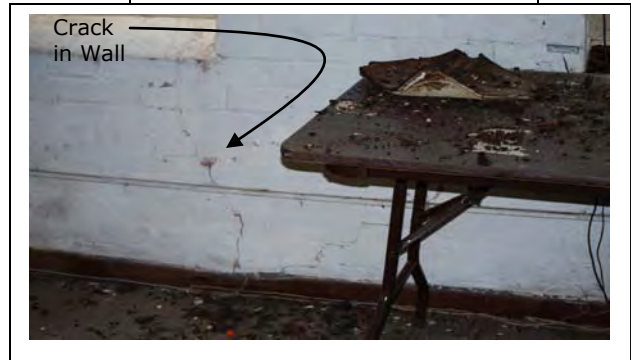
Area No.7 (1915) First Floor  
Framing Photo 5.70

- A brick has been knocked out of the wall above the door opening in the corridor that connects Area 2 and Area 7. See **Photo 5.112.**
- A crack exists in the brick wall at the south west corner of Area 7. See **Photo 5.70.**

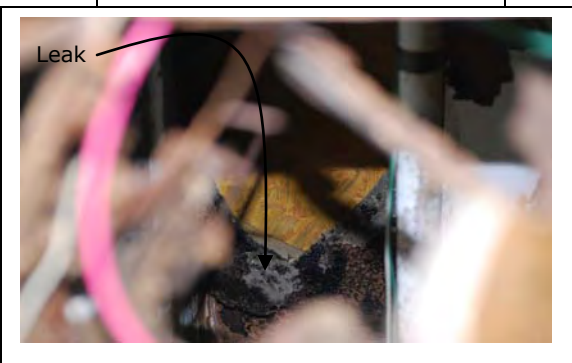
Area NO.7 (1915) Roof Framing  
Photo 5.71

- Water infiltration has occurred behind the in the southwest corner of Area 7 where the wood decking has deteriorated. See **Photo 5.71.**
- Water damage has occurred in the southwest corner of Area 7 and has caused the wood floor framing to rot. See **Photo 5.72.**

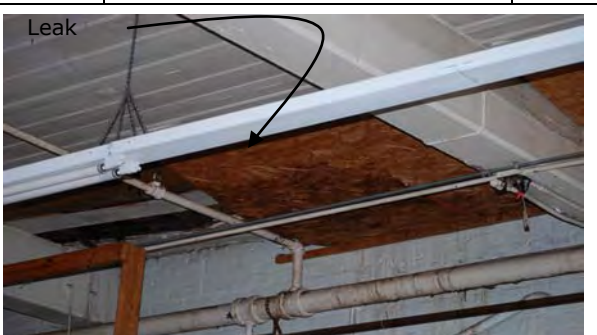
Area NO.7 (1915) Roof Framing  
Photo 5.79

- Water damage has occurred at the east wall of Area 7 between grids 10 and 11 and has caused the wood roof decking to rot. See **Photo 5.78.**
- Water damage has occurred at the west wall of Area 7 between grids 11 and 12 and has caused the wood roof decking and wood beam to rot. See **Photo 5.79.**

- At locations noted that have leaks, roofing to be repaired immediately. Rotten wood framing members at leaks to be removed and replaced to match existing conditions.
- Roofing system to be replaced within five years.
- All roof drains to be checked for clogs
- All downspouts to be connected and to discharge at grade away from the building
- Additional roof drains and downspouts to be added
- At location of Photo 5.94, install (2)5/8" diameter A36 thru bolts into existing steel clip angles and wood beam
- All existing roofing to be removed and replaced with a new roofing system
- Remove and replace locations of rotten wood fascia and soffit.
- Remove and replace locations of rotten wood fascia and soffit at clerestory conditions.

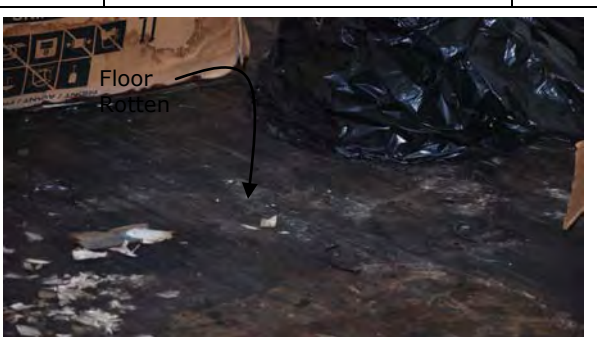
- Water damage has occurred at the west wall of Area 7 between grids 11 and 12 and has caused the wood flooring to rot. See **Photo 5.80.**
- Standing water is present on the 1<sup>st</sup> floor between grids 7 and 8. See **Photo 5.81.**

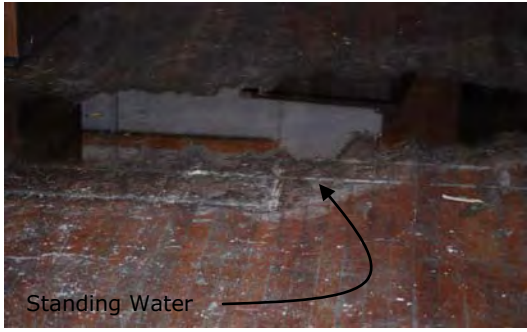
Area NO.7 (1915) First Floor  
Framing Photo 5.81

Standing Water

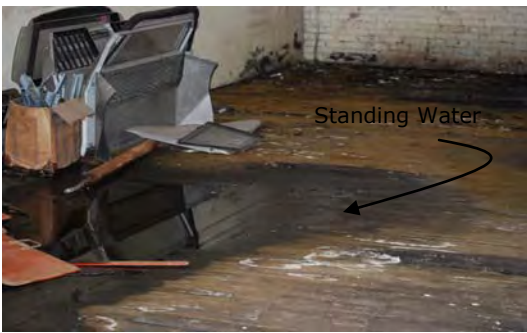
Area NO.7 (1915) Roof Framing  
Photo 5.87

- Standing water is present on the 1<sup>st</sup> floor between grids 6 and 7. See **Photo 5.87.**
- Water damage has occurred at the west wall of Area 7 and has caused the wood roof decking to rot. See **Photos 5.88 & 5.89.**

Standing Water

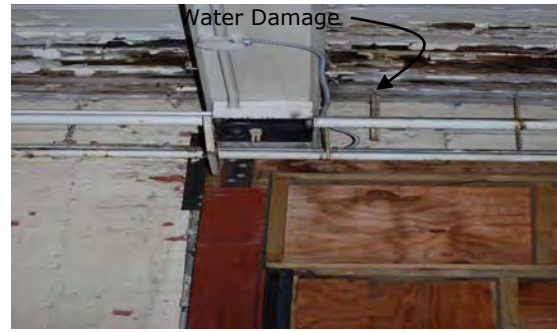
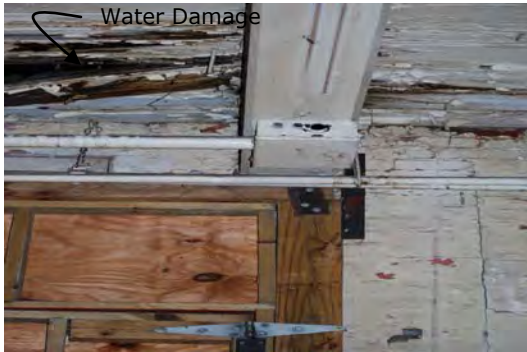
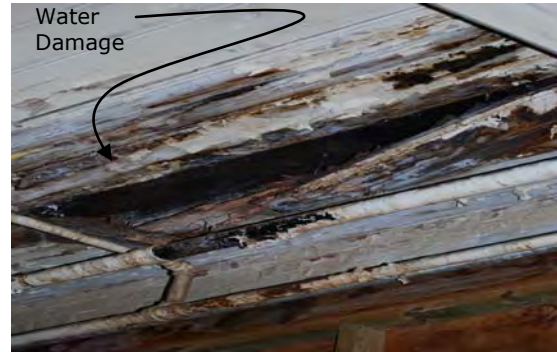
- Water damage has occurred at the west wall of Area 7 between grids 4 and 5 and has caused the wood roof decking to rot. See **Photos 5.90 – 5.92.**
- Water damage has occurred at the east wall of Area 7 between grids 6 and 7 and has caused the wood roof decking to rot. See **Photo 5.93.**

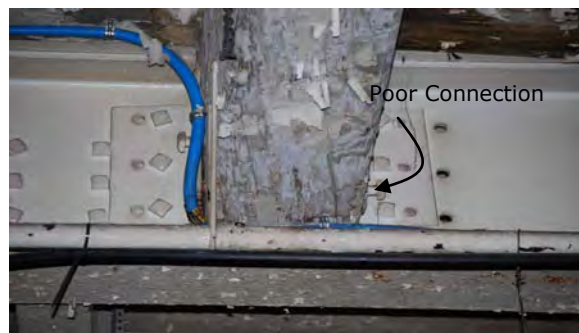
Area NO.8 (1947) Roof Framing  
Photo 5.95

- The connection of the wood beam to steel beam between grids 4 and 5 needs additional support. See **Photo 5.94.**
- Water damage has occurred at the east wall of Area 7 between grids 4 and 5 and has caused the wood roof decking to rot. See **Photos 5.96.**

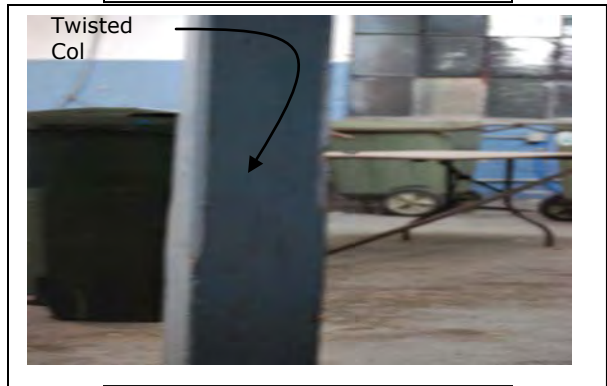
Area NO.3 (1947) First Floor  
Framing Photo 5.108

- The 8"x8" wood column on grid 5.2 has twisted. See **Photo 5.108**.
- Water damage has occurred near grid 5.4 and has caused the wood decking to rot. See **Photo 5.113**.
- The flanges of the steel W6 column on grids G-6 are dented or slightly buckled most likely from forklift traffic. See **Photo 5.114**.
- Water damage has occurred at the louver between grids 4.1 and 5.4. The louver has rusted as a result. See **Photo 5.115**.

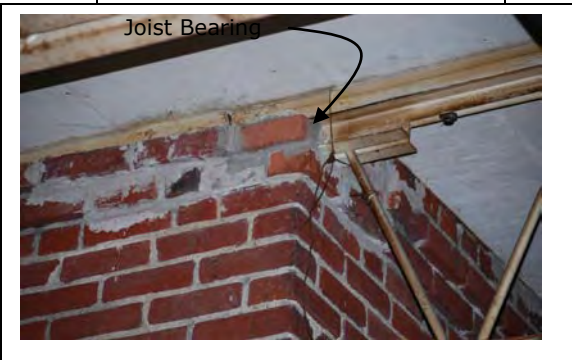
Area NO.5 Roof Framing Photo  
5.117

- Existing joist bearing on brick condition will need to be replaced. See **Photo 5.117**.
- The plywood roof sheathing is spanning 48" between the steel joists, which exceeds the allowable span for plywood sheathing under this loading. See **Photo 5.118**.
- Water damage has occurred in the southwest corner of Area 5 and has caused the plywood roof sheathing to rot and the brick bearing wall to deteriorate. See **Photo 5.120**.

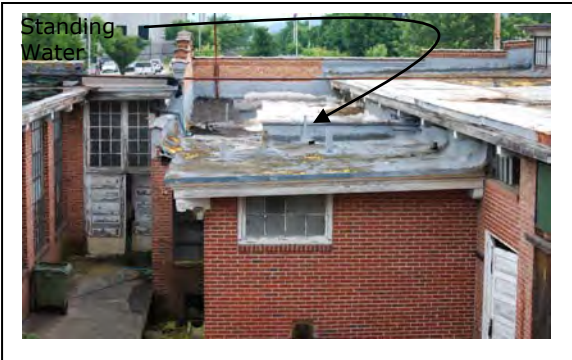
Photo 6.1-Area 6

- Roofing/drainage system – spray polyurethane foam (SPF); scuppers and interior roof drains
- New roofing is required over the entire extents of Area 6. See **Photo 6.1.**

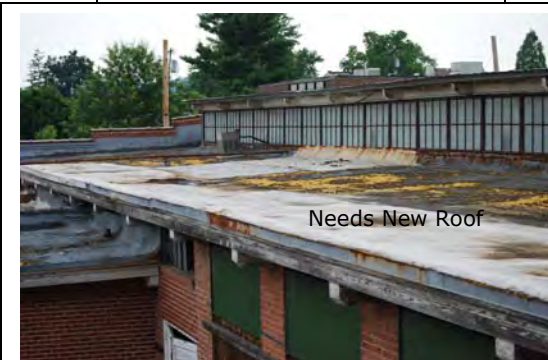
Photo 6.3-Area 7

- Roofing/drainage system – spray polyurethane foam (SPF); scuppers and interior roof drains
- New roofing is required over the entire extents of Area 7. See **Photos 6.3, 6.11-6.15, & 6.17.**
- The roof drain appears to be clogged. See **Photo 6.14.**
- The soffit around the entire perimeter of the Area 7 clerestory has rotted and will need to be replaced. See **Photos 6.16, 6.19-6.24.**
- Cracks exist in several window panes at the clerestory windows. See **Photo 6.18.**

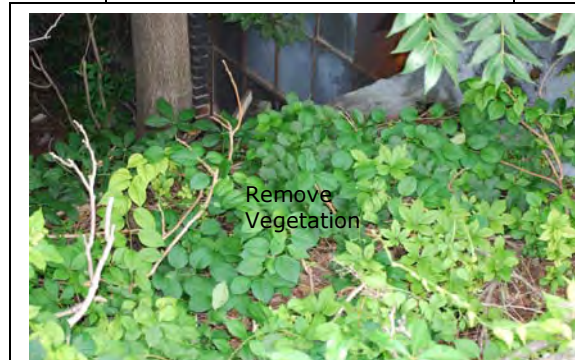
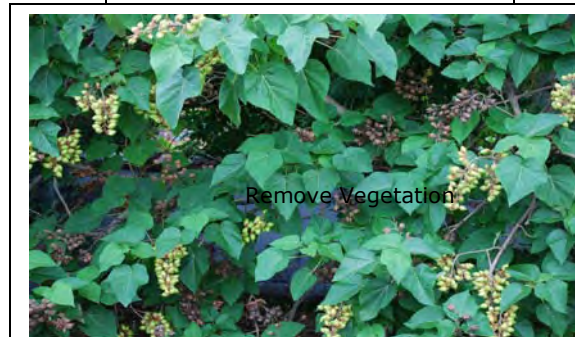
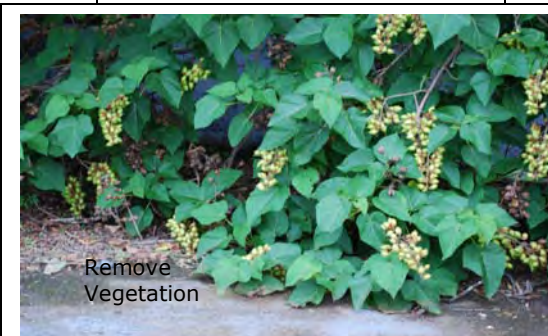
- Roofing/drainage system – spray polyurethane foam (SPF); scuppers and interior roof drains
- The roof of Area 3 carries an excessive amount of vegetation that needs to be removed. See **Photos 6.4, 6.6, & 6.7.**

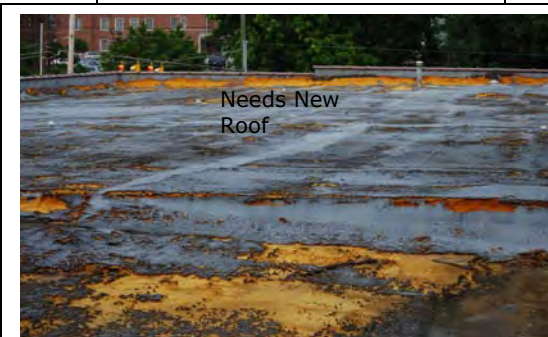
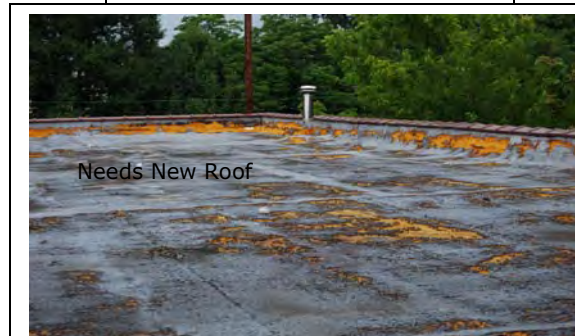
- Roofing/drainage system – spray polyurethane foam (SPF); scuppers and interior roof drains
- New roofing is required over the entire extents of Area 8. See **Photos 6.5, 6.8-6.10.**

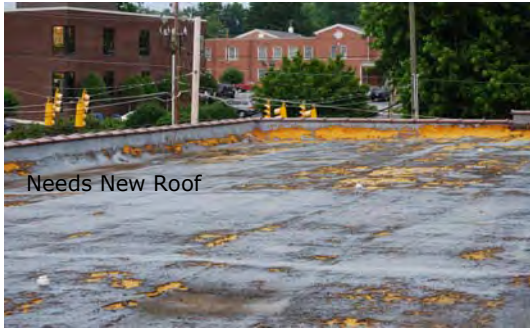
Photo 6.9-Area 8

Needs New Roof

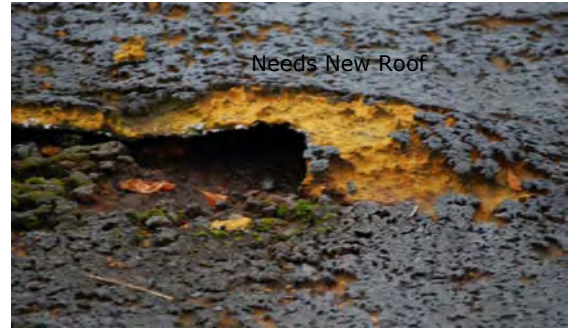
Photo 6.10-Area 8

Needs New Roof

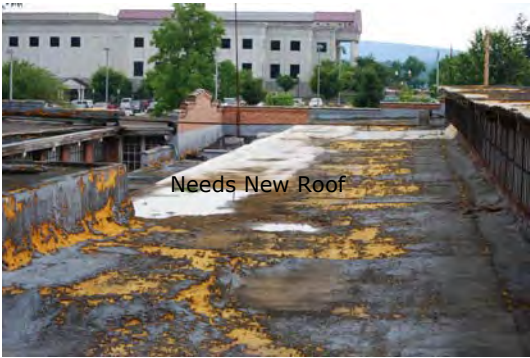
Photo 6.11-Area 7

Needs New Roof

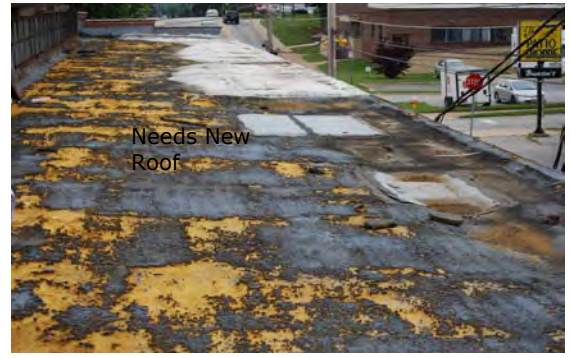
Photo 6.12-Area 7

Needs New Roof

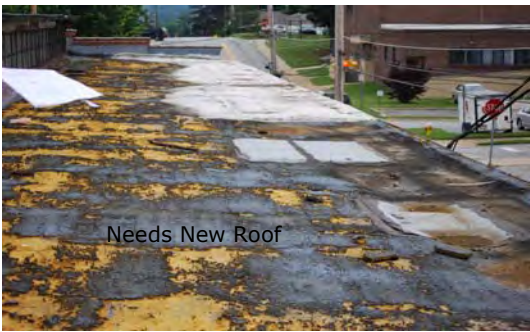
Photo 6.13-Area 7

Needs New Roof

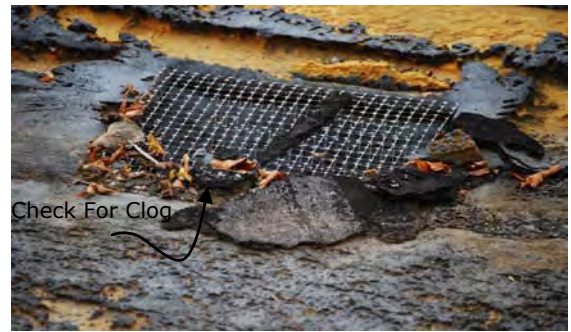
Photo 6.14-Area 7

Check For Clog

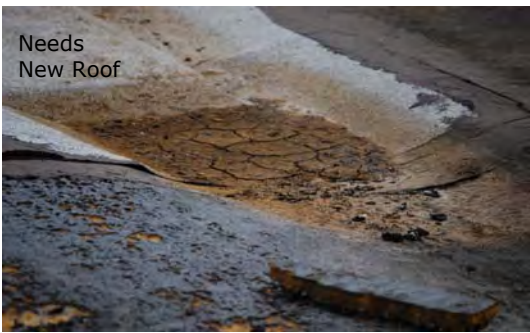
Photo 6.15-Area 7

Needs New Roof

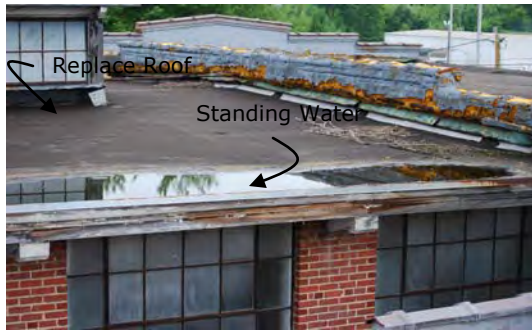
Photo 6.25-Area 2

- Roofing/drainage system – membrane roofing, insulation board not verified; scuppers and interior roof drains
- New roofing is required over the entire extents of Area 2. See **Photos 6.25–6.29, 6.36, 6.38–6.41.**
- Ponding is prevalent at nearly all edges of the roof at Area 2. See **Photos 6.25–6.29, 6.40–6.41**

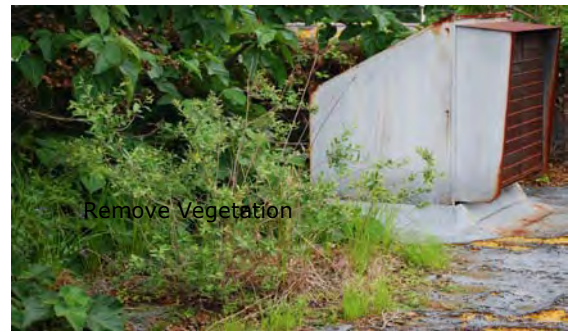
Photo 6.30-Area 5

- Roofing/drainage system – spray polyurethane foam (SPF); scuppers and interior roof drains
- New roofing is required over the entire extents of Area 5. See **Photos 6.31 & 6.35.**
- The roof of Area 5 carries an excessive amount of vegetation that needs to be removed. See **Photos 6.30 & 6.32.**

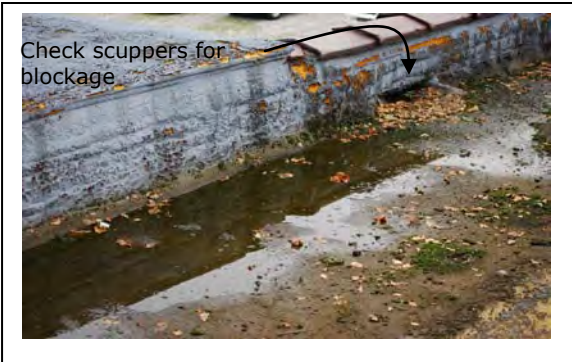
Photo 6.33-Area 4

- Roofing/drainage system – spray polyurethane foam (SPF); scuppers and interior roof drains
- Ponding is prevalent around the perimeter of Area 4 roof. See **Photos 6.33 & 6.34.**
- New roofing is required over the entire extents of Area 4. See **Photos 6.33, 6.34 & 6.37.**

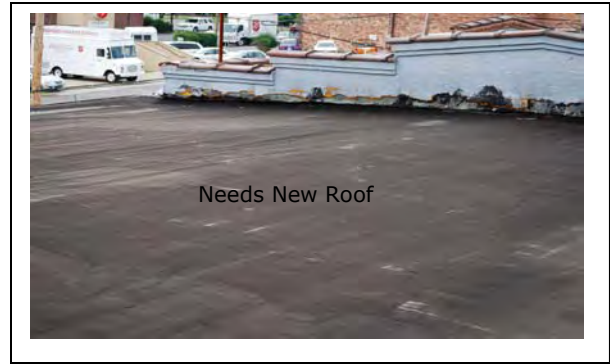
Photo 6.42-Area 1

- Roofing/drainage system – membrane roofing, insulation board not verified; scuppers and interior roof drains
- New roofing is required over the entire extents of Area 1. See **Photos 6.42, 6.43, & 6.45.**
- Ponding is prevalent in several locations on the roof of Area 1. See **Photos 6.44 & 6.46.**
- The roof drain at Area 1 appears to be clogged. Considerable ponding has resulted. See **Photo 6.47.**
